# ANALYSES OF MORTARS FROM ST. GEORGE'S CATHEDRAL, GREAT NOVGOROD

## A VELIKIJ NOVGORODI SZT. GYÖRGY-KATEDRÁLIS HABARCSAINAK VIZSGÁLATA •

### Abstract

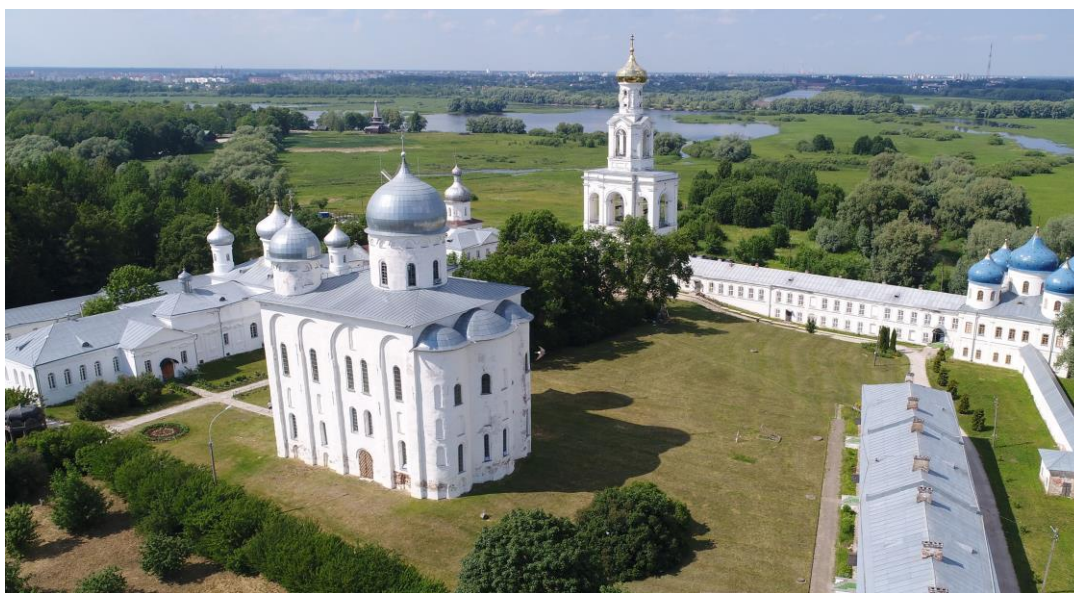
**Fig. 1.:** St. George Cathedral and the Yuriev Monastery. View from South-East.

The St. George's Cathedral in the Yuriev Monastery (**Fig. 1**) is one of the largest churches at Veliky Novgorod. According to the chronicles, it was built in 1119 by Prince Vsevolod Mstislavich (grandson of Vladimir Monomakh) and Archbishop Kiriak. The name of the master-builder, Peter (NPL, 6627), is also known. The mention of the name of the builder is quite a rare circumstance in Russians chronicles, indeed, only four are known (Rappoport 1994, 127). Apparently, this cathedral was an important project for the Novgorodian authorities. The Yuriev Monastery belongs to the area registered as UNESCO World Heritage Site in 1992, under the name "Historic Monuments of Novgorod and Surroundings (UNESCO 1992)".

The nowadays exterior of the Cathedral is a result of the restoration in the 1930s (**Fig. 1**). During the archaeological excavations of 2013–2021 inside the Cathedral, the 12<sup>th</sup> century floor made of limestone slabs, the Cintron with the Bishop's throne, three altars (in three apses), the underground tomb in the Narthex etc. were brought to light. In addition, more than 400 thousand fragments of fresco paintings, that had been knocked down and used as filler under the iron floor during the global reconstruction in 1825–1827, were found (Sedov et al. 2016). Now, almost all these constructions are open and visible, waiting for restoration (**Fig. 2**).

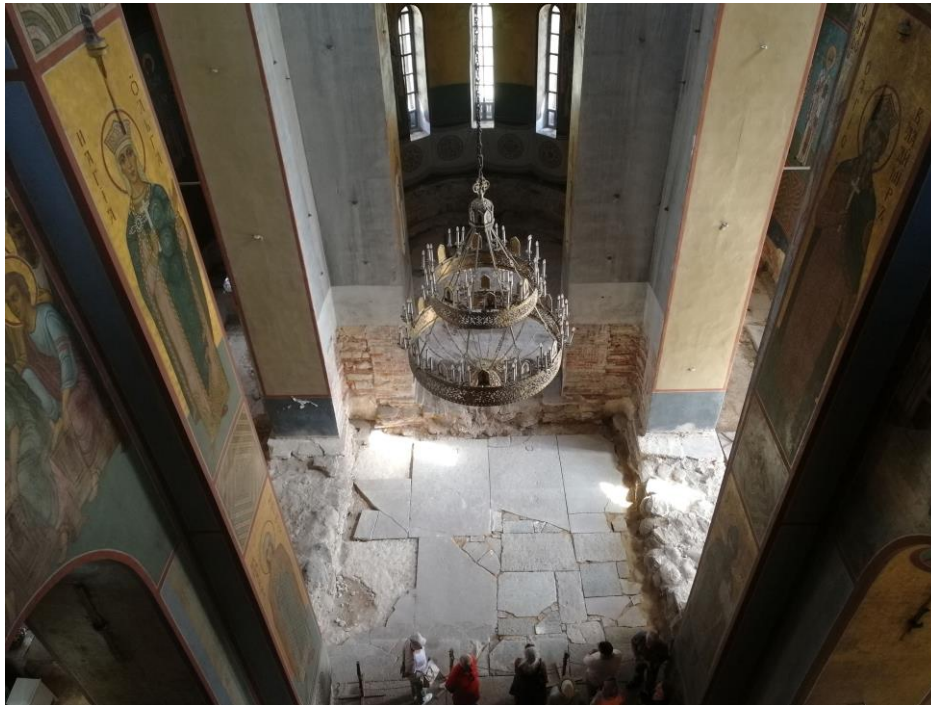
**Fig. 2.:**  
St. George Cathedral.  
Eastern part.  
Excavated constructions.  
View from Western gallery

The binder of all samples is composed of calcite and has micritic structure (Figs. 4–6). The binder of some pre-Mongolian mortar samples (S-8, S-13, S-17) contains cracks "healed" by crystallized lime (Fig. 5b, Fig. 6c-d). This phenomenon could be the result of pozzolanic reaction in the binder appeared as regenerative cementitious resilience that discovered in Roman pozzolanic cements (Jackson et al. 2017). Most cracks were detected in the floor mortar (S-8) which was under pressure of stone floor slabs (Fig. 2).

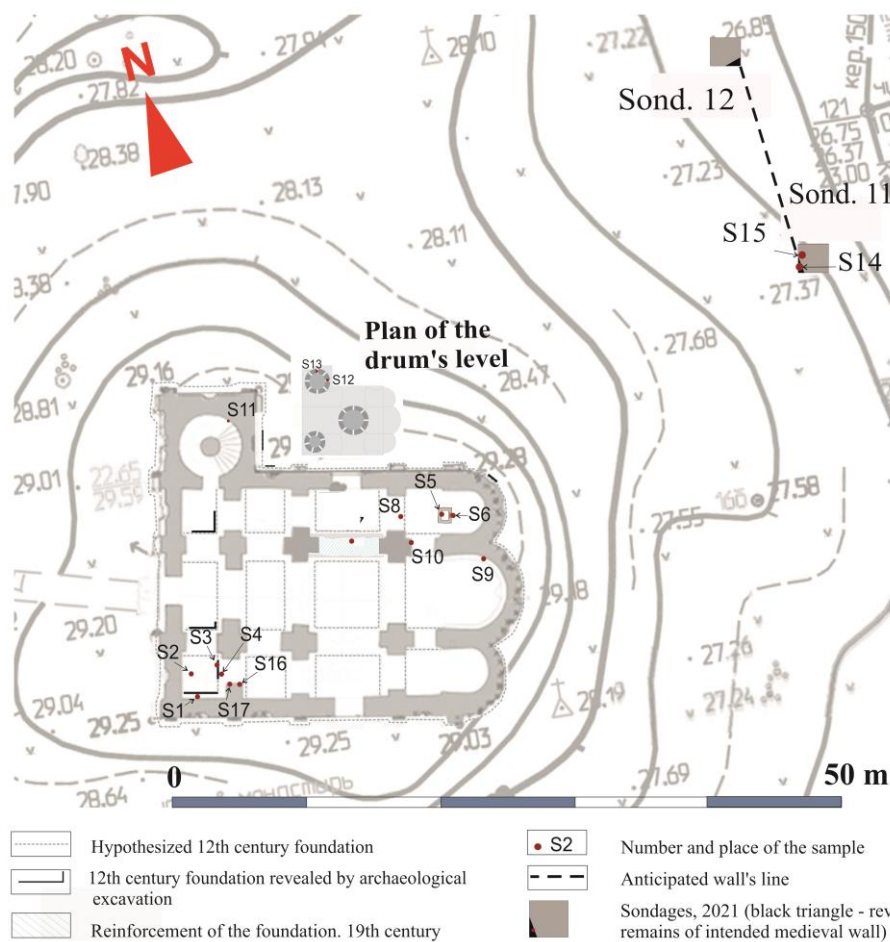
**Fig. 3.:**  
St. George Cathedral of the Yuriev Monastery. Plan with the samples

During the 2021 excavation on the territory of the Monastery, 17 mortar specimens were collected from structural walls and foundations, flooring and plastering. Four samples come from different foundation constructions, discovered in the south-western underground tomb (S-1, S-2, S-3, S-4). Two mortar samples were collected from the northern altar, apparently built after the erection of the Cathedral: one from the actual altar (S-5) and one from a later phase on top of it (S-6). Two samples were taken in the northern gallery: one from the strip foundation under the base of the columns of the 19<sup>th</sup> (S-7) and the second from the filling under the floor of the 12<sup>th</sup> century (S-8). Two more samples come from the crimson plaster in the main apse (S-9), and one from the Eastern wall (S-10). One sample was taken from the wall of the Tower between the first and second floor (S-11). Two mortar samples were collected from the walls of the Chapel above the Tower (S-12, S-13) and two more from the South-West semi-pillar (in the narthex) that has an additional part of unknown date (S-16, S-17). Two samples of mortar from constructions with unknown function and date were taken from Sondage 11 (S-14, S-15) (**Fig. 3**).

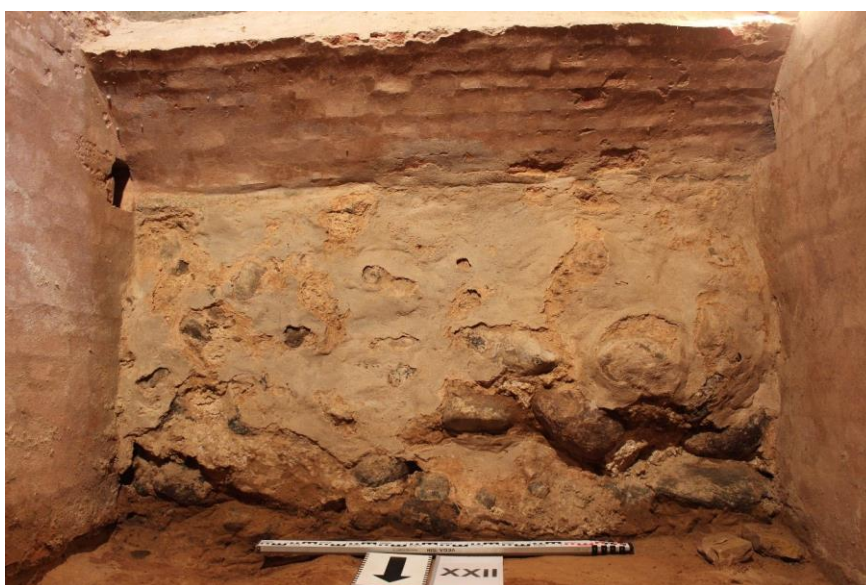
**Fig. 7.:**  
South-West Tomb.  
Foundation. South  
wall. View from the  
North

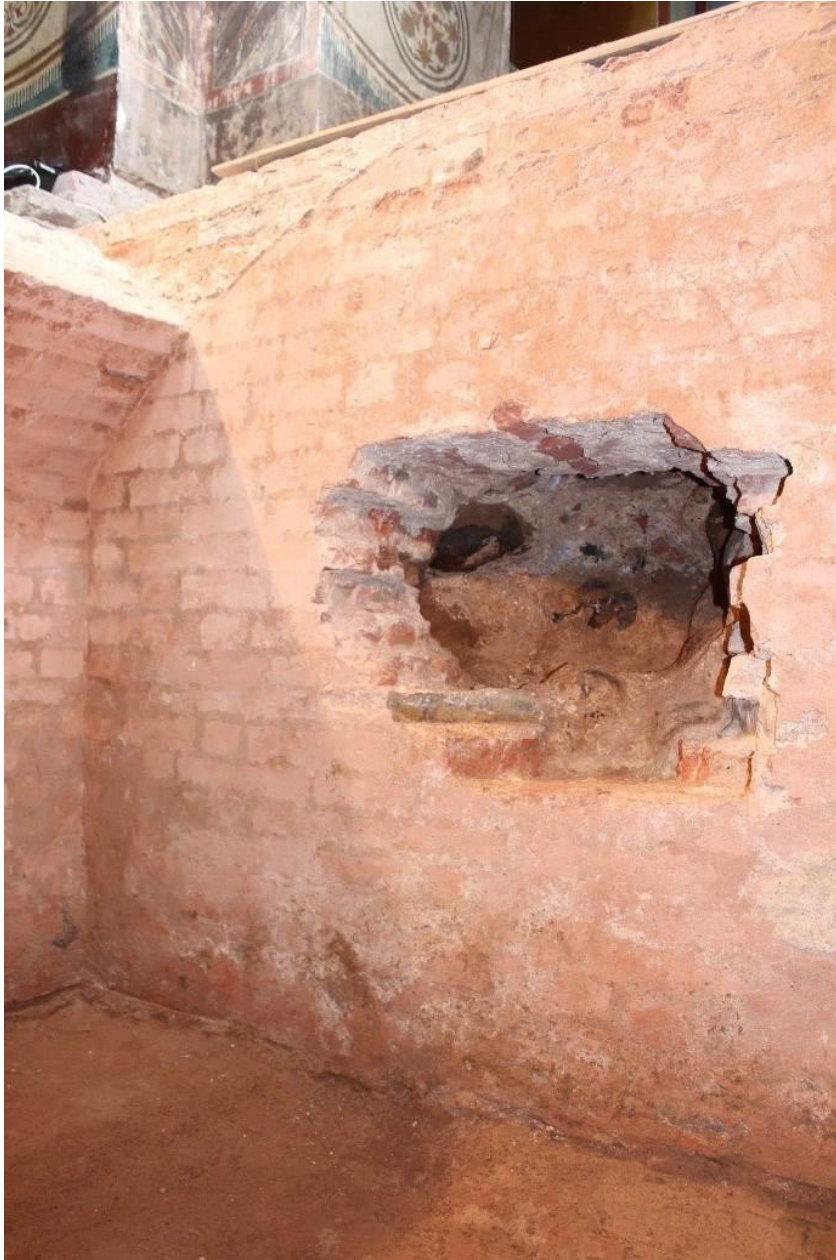
**Fig. 8.:**  
South-West Tomb.  
Strip foundation  
between semi-pillar  
and column, 12th  
century. View from  
the South-West

Samples S-2 and S-4 from the 12<sup>th</sup> century foundation (**Fig. 8**) are similar, with a large amount of brick fragments (0.3 to 5 cm in length) and a very small amount (around 5%) of sand, mainly consisting of monomineralic quartz. Organic material (possibly wood) is present in both samples. It is important to note that lime lumps which could be the fragments of earlier mortars (with angular shape) are also present in these samples.

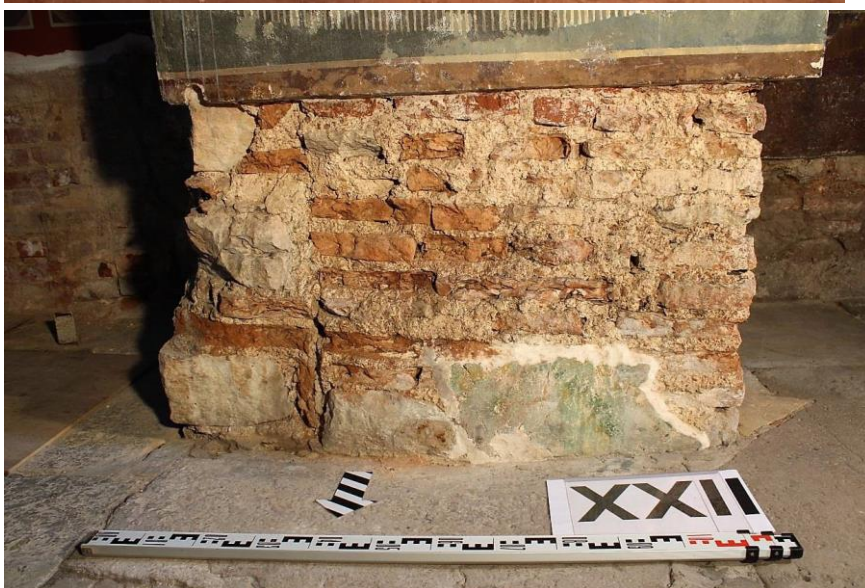
**Fig. 9.:**  
South-West semi-  
pillar. Vertical seam in  
the center of the pillar.  
View from the North
