ANALYTICAL CHARACTERIZATION OF AN OTTOMAN OPUS SECTILE MOSAIC FLOOR FROM THE DELTA REGION, EGYPT

ADLY, Rehab Zohdy¹; EL BELEIHY, Wael Zakaria¹ & MAREY MAHMOUD, Hussein²

¹ Administration of Restoration, Ministry of Tourism and Antiquities, Egypt

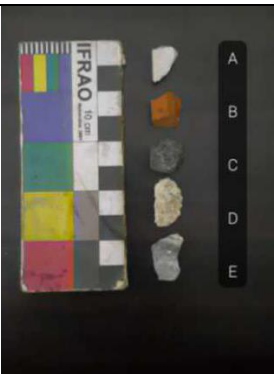
Sample	Description	Photographic description
A	White marble sample from the mosaic structure (approx. dimensions: 1x1.5 cm ²)

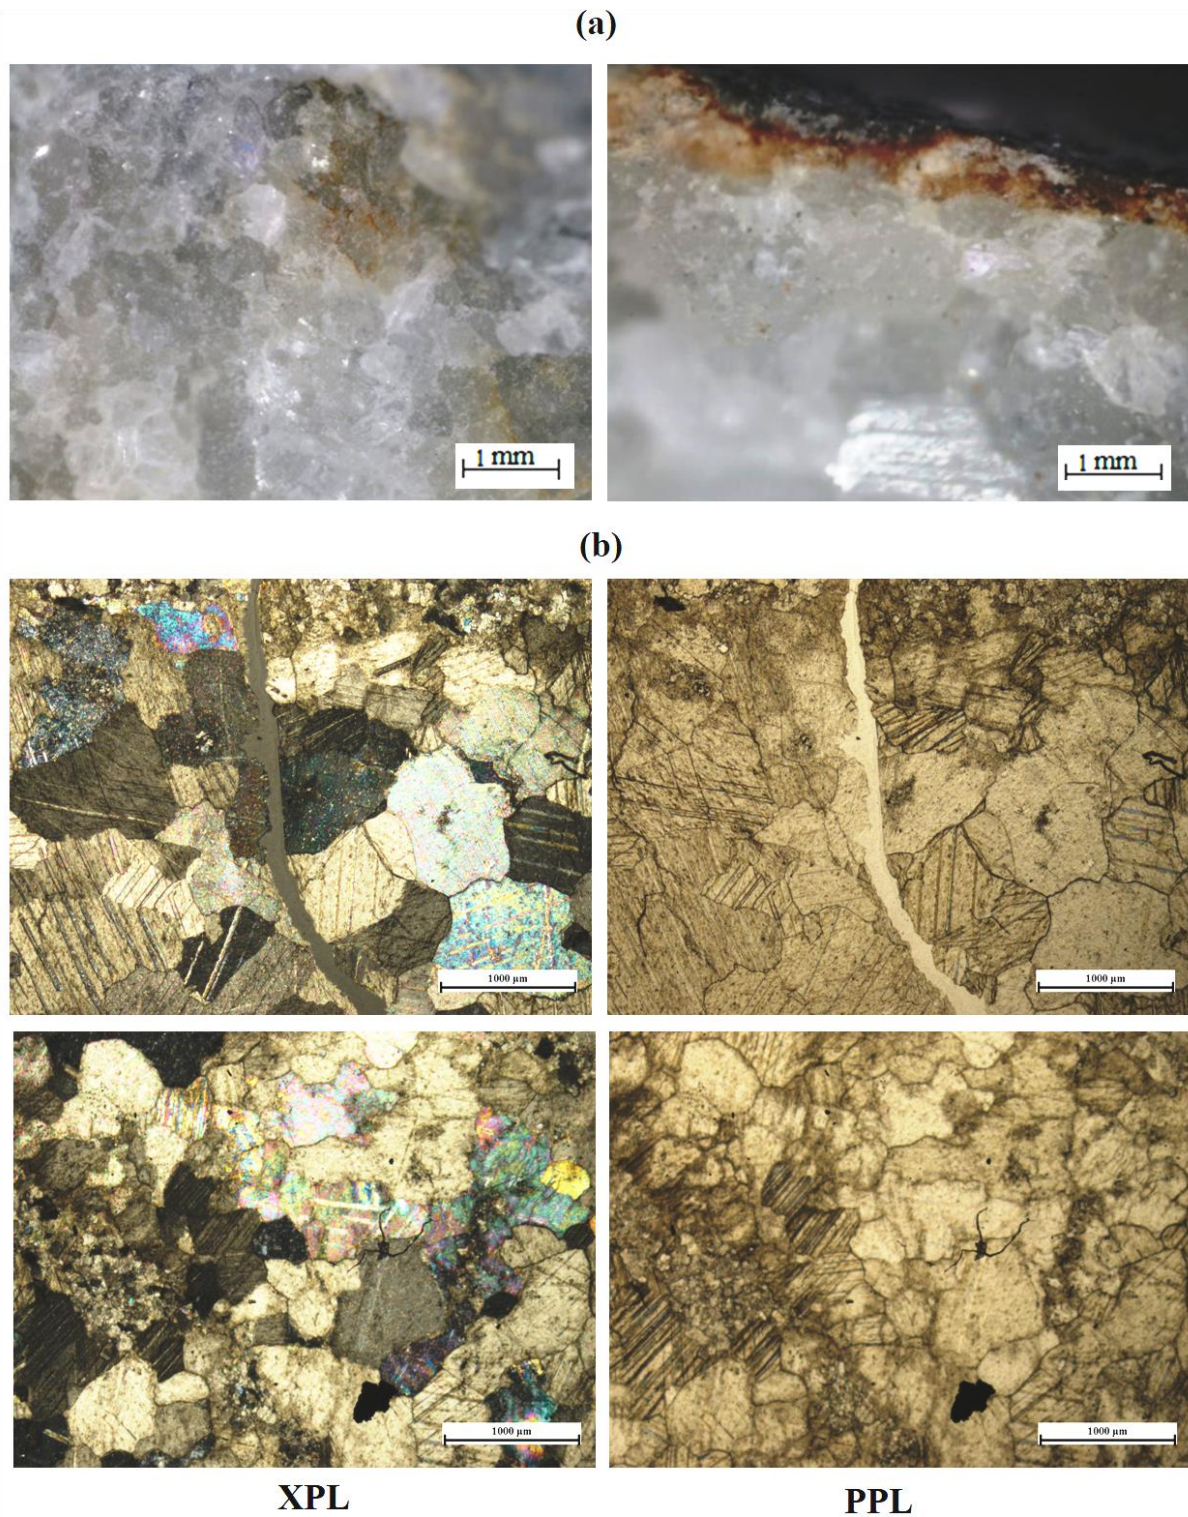
Fig. 5: a) Microscopic images obtained on the marble samples, b) Petrographic images obtained on the marble thin-sections (left: under cross-polarized light; right: under plane-polarized light).

The microscopic images obtained on the white stone (sample A) showed the appearance of clear white crystals. Furthermore, a thin orange-brown layer was observed on the surface, probably developed due to deterioration processes (**Fig. 5a**). The examination of the sample under cross and plane-polarized lights showed cloudy to white color multi-sized crystals which appear in a rhombic or scalloped shape. The examination of the section under the cross-polarizers (on the left) shows elongated and anisotropic shape grains. The plated calcite crystals (CaCO₃) with different sizes showed granoblastic with equidimensional shapes. Their interference colors are from white to gray and sometimes the thin edges appear as bright colors.

The sample clearly showed a cleavage under the plane-polarized light while a typical lamellar twinning was observed under the cross-polarized light (**Fig. 5b**).

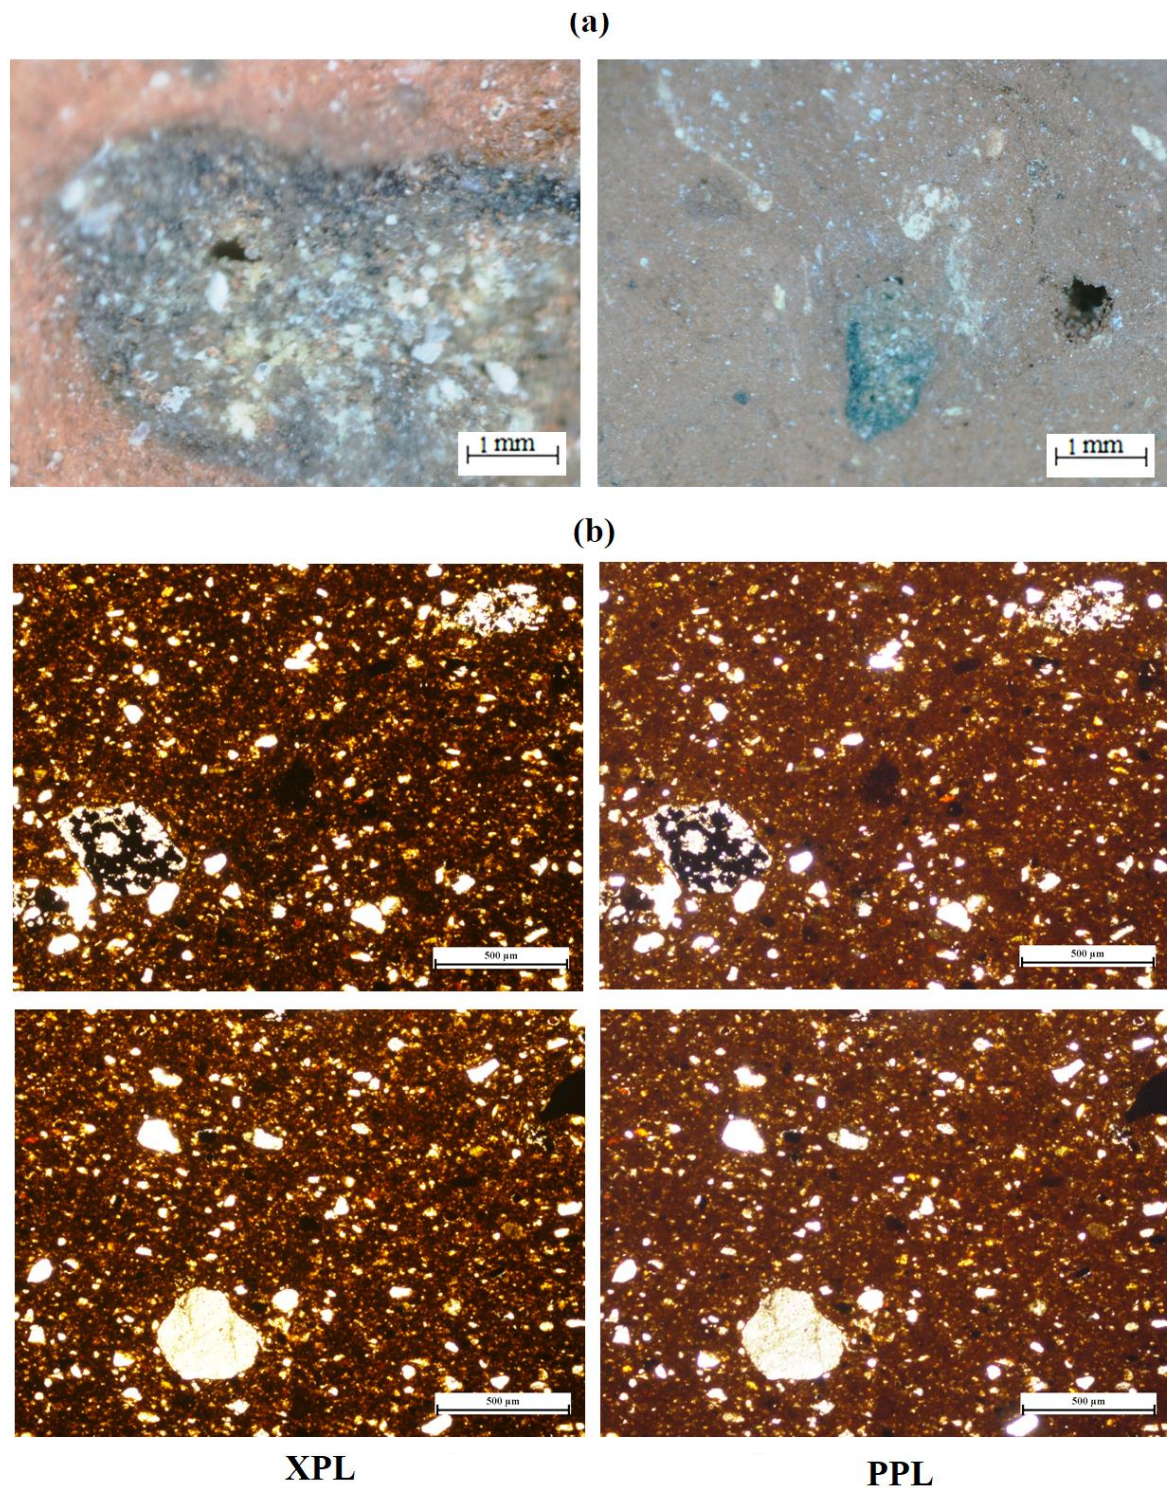
Fig. 6: a) Microscopic images obtained on the pottery samples, b) Petrographic images obtained on the pottery thin-sections (left: under cross-polarized light; right: under plane-polarized light).

The microscopic examination of the pottery mosaic pieces (sample B) showed a heterogeneous structure containing holes, impurities, fine cracks and clusters (**Fig. 6a**). Also, signs of biological damage and salt efflorescence were observed. The petrography of the sample, under the plane-polarized light (on the right), shows a dark red color with texture contains round-sharp edged quartz crystals, while under the cross-polarized light (on the left), the sample appears with a brownish-yellow color, probably due to iron oxides pigmentation. More, many feldspar crystals are scattered with a cloudy color tending to yellow (**Fig. 6b**). In case of the black stone (sample C), dark and pale gray grains with white and orange appearance were noticed (**Fig. 7a**). The petrographic observations on the sample showed a white to cloudy color and opaque areas, and under the plane-polarized light, it shows separation/cleavage, while under the cross-polarized light, several interferences appeared with white to grey, greenish, bluish and reddish colors. The crystals in the section appeared flat and compressed with some blades. They also appear as long and short prismatic crystals. The presence of siliceous minerals and the lamellar twinning of plagioclase feldspars are characteristics for the basic components of igneous and metamorphic rocks (MacKenzie & Guilford 1980) (**Fig. 7.b**). The microscopic examination of the setting bed mortar (sample D) showed siliceous grains with different sizes. Also, some dark particles of charcoal or vesiculated volcanic fragments are visible within the white binder. Some interstitial voids together with salt crystals appeared clearly in the mortar (**Fig. 8a**). Under the plane-polarized light, the quartz aggregates appear colorless with some fine cracks. The binding lime material appears in brown color, and the pores or air spaces appear in yellow, while under the cross-polarized light, interference colors from white to grey are observed (Balksten 2007) (**Fig. 8b**).

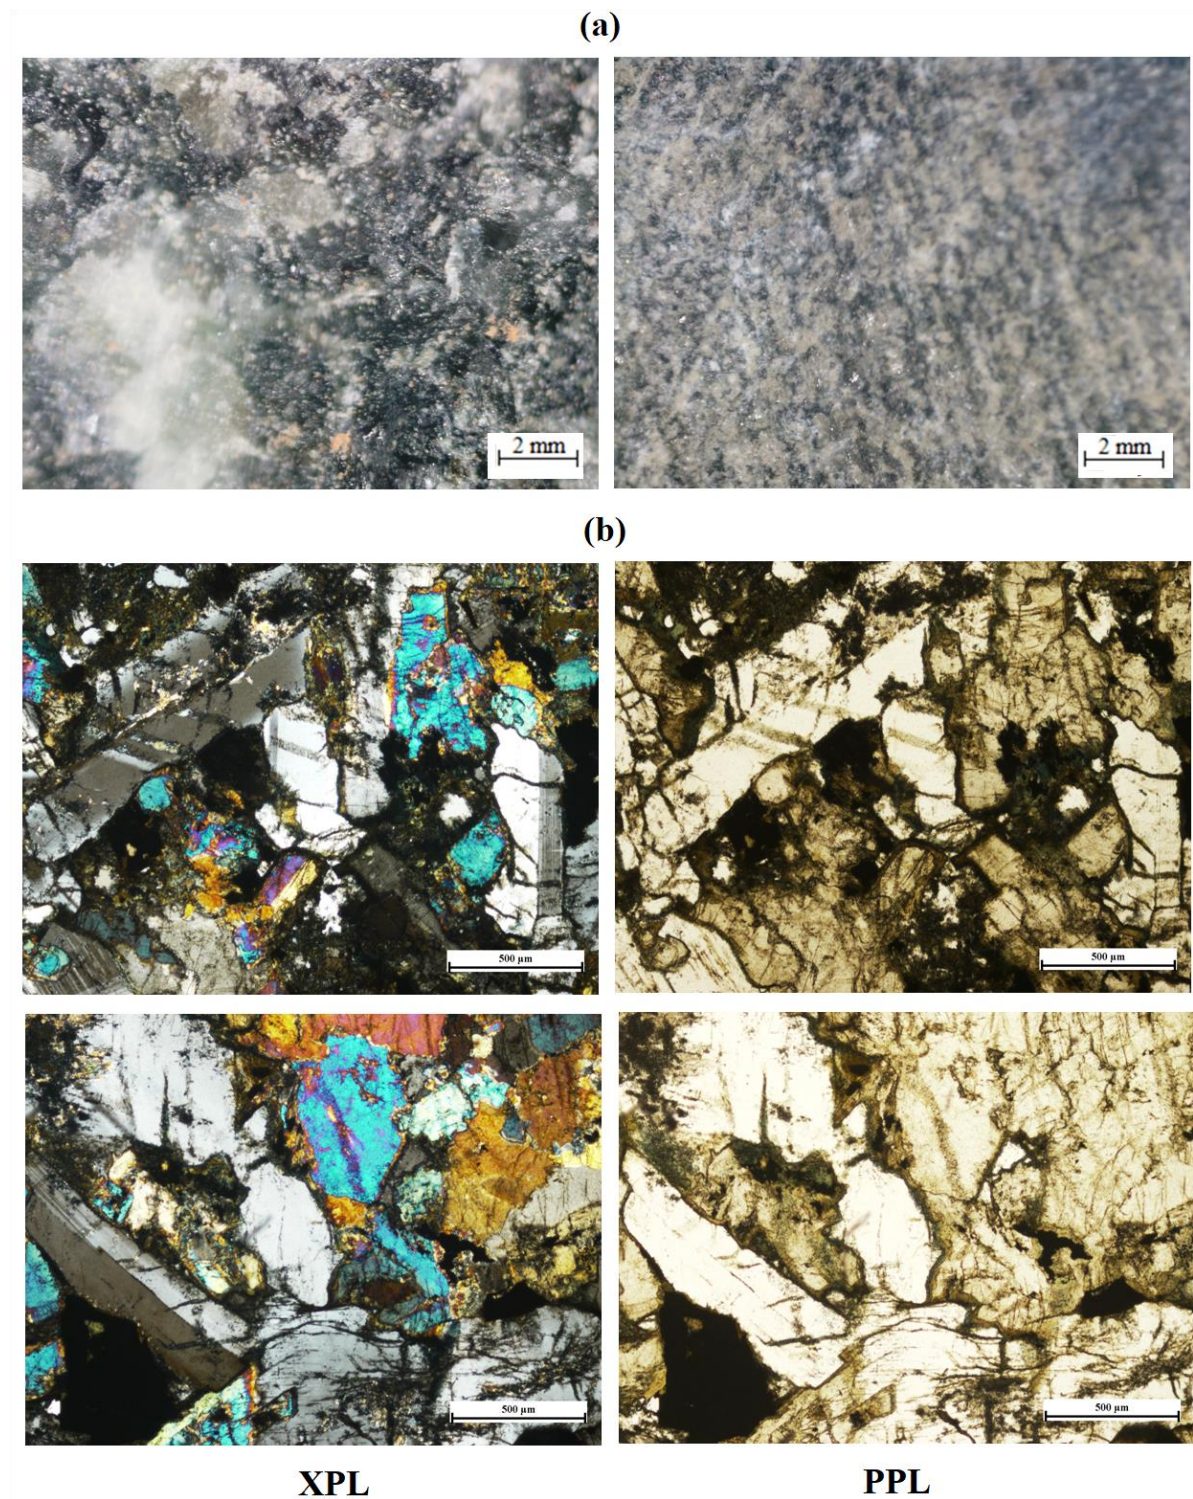
Fig. 7: a) Microscopic images obtained on the black stone sample, b) Petrographic images obtained on the basalt thin-sections (left: under cross-polarized light; right: under plane-polarized light).

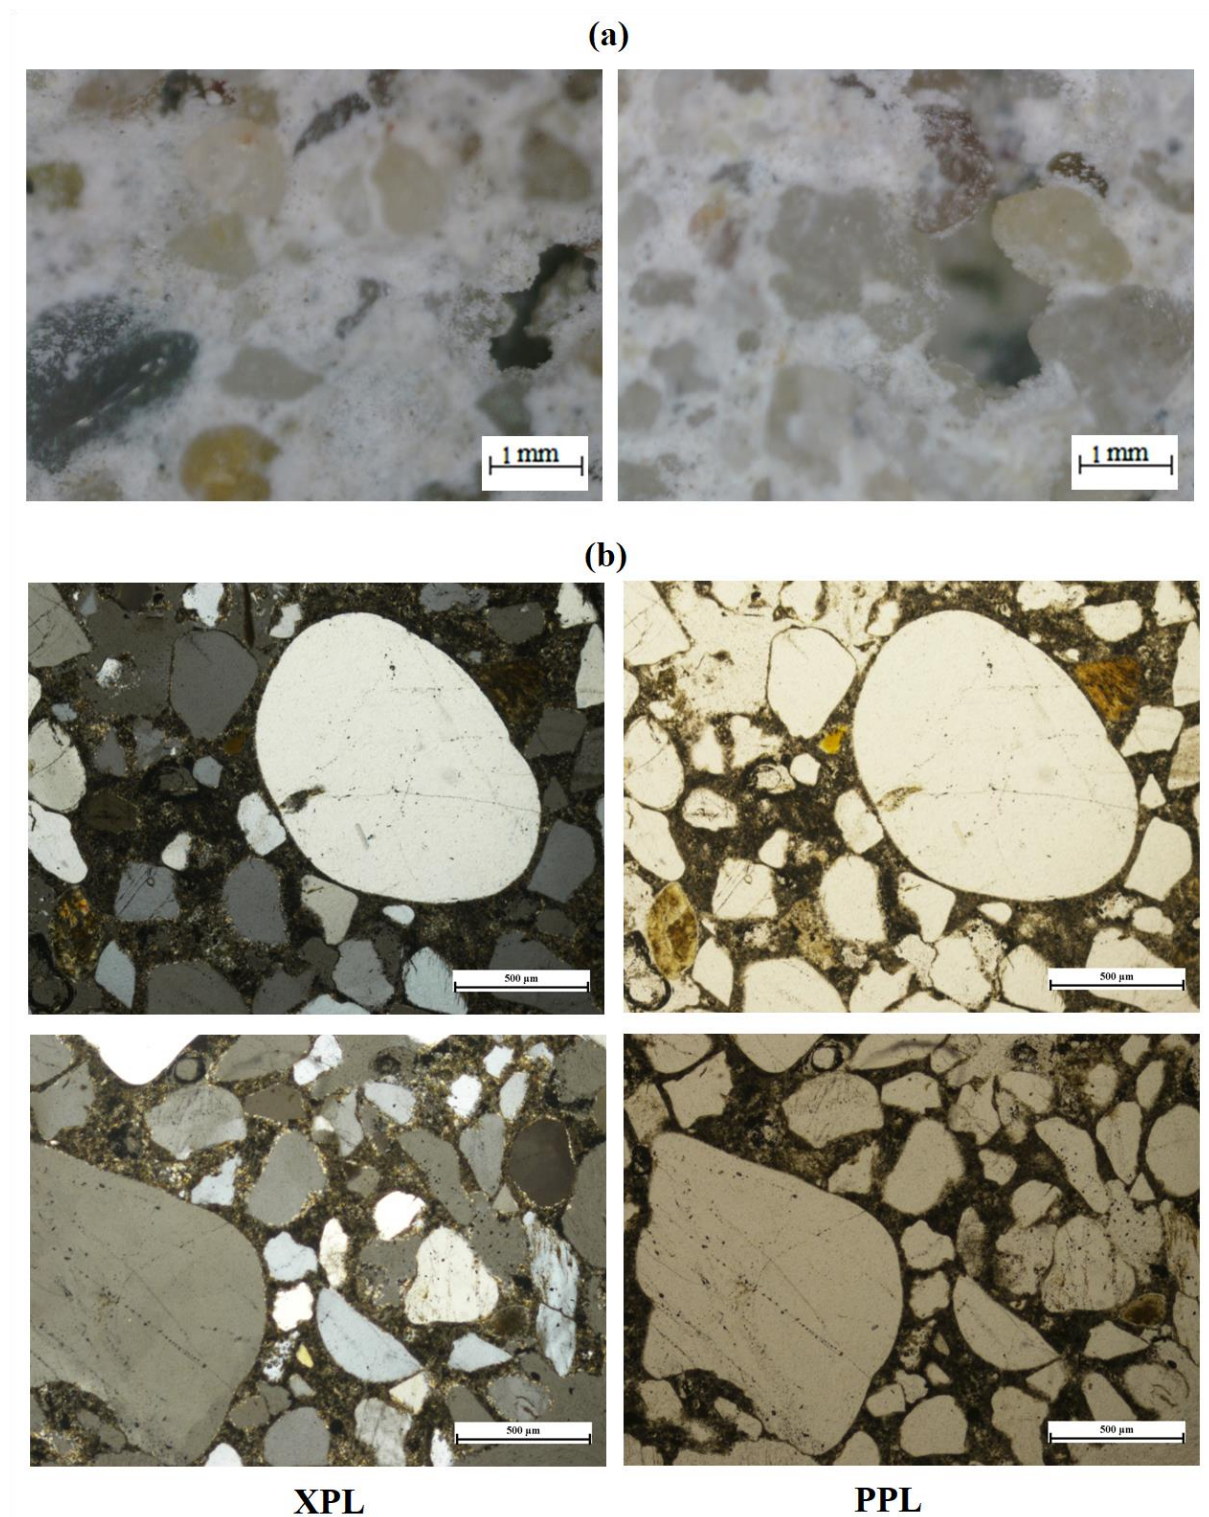
Fig. 8: a) Microscopic images obtained on the setting bed mortar, b) Petrographic images obtained on the mortar thin-sections (left: under cross-polarized light; right: under plane-polarized light).

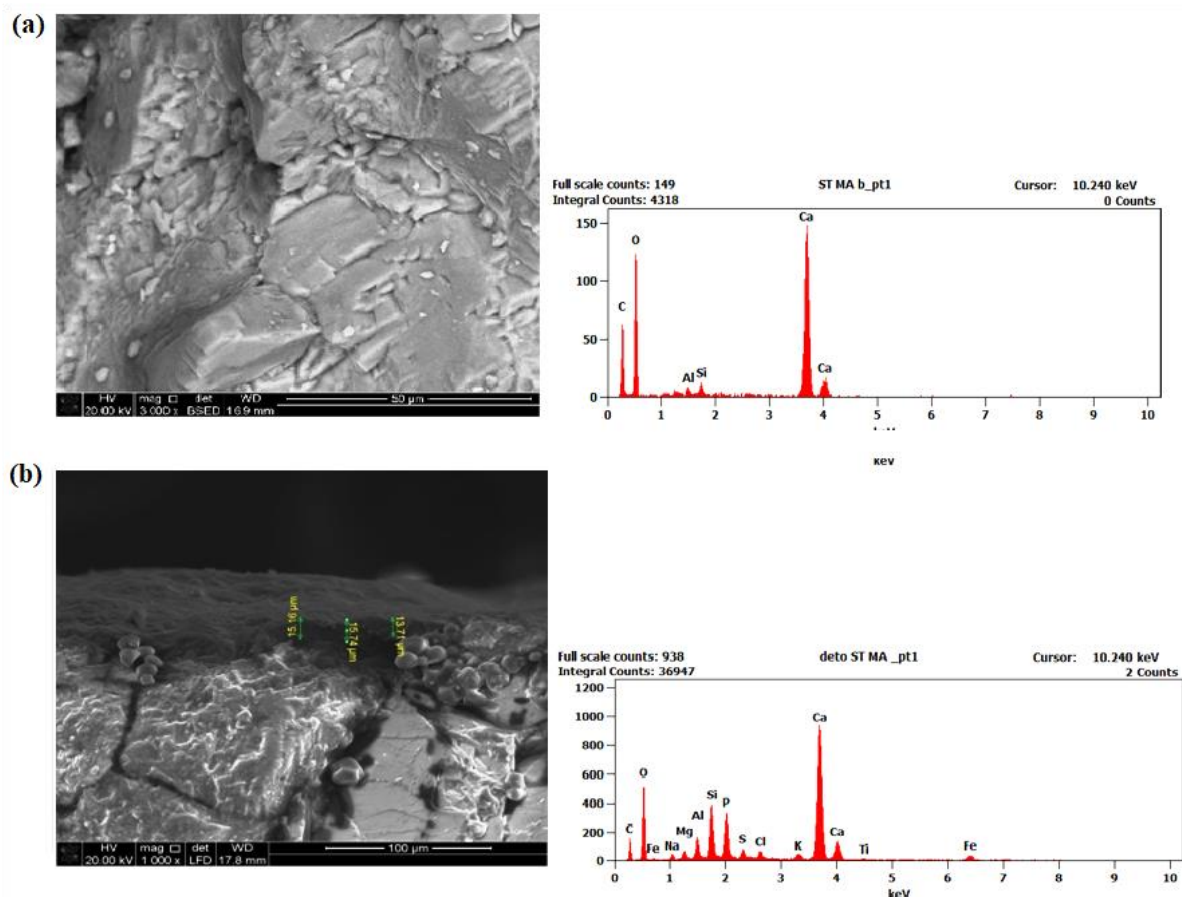
Fig. 9: a) SEM-SE micrograph (3000x, scale bar= 50 μm) and EDX spectrum obtained on the marble sample, b) SEM-SE micrograph (1000x, scale bar= 100 μm) and EDX spectrum obtained on a cross-section of the encrustation formed on the marble surface.

SEM investigation of the marble sample (**Fig. 9a**) showed a firm compacted structure. EDX microanalysis of the sample revealed a major concentration of calcium (Ca) with traces of silicon (Si) and aluminum (Al). The investigation of a cross-section of the sample (**Fig. 9b**) showed an irregular encrustation with an average thickness= 20 µm. The EDX analysis of this layer showed elements of calcium (Ca), silicon (Si), phosphorus (P), aluminum (Al), magnesium (Mg), sulphur (S), iron (Fe), chlorine (Cl) and sodium (Na).

The occurrence of these elements suggests that the layer is composed of chloride and sulphate salts together with biological and iron oxide deposits. The morphology of the pottery mosaic pieces showed a heterogeneous surface with a number of fractures. EDX analysis of the sample detected elements of silicon, aluminium, iron, magnesium, sodium, potassium (K) and titanium (Ti) (**Fig. 10a**). The morphology of the black stone sample appears as laminated large crystals with some cracks. The analysis of the sample showed the presence of major concentrations of silicon and aluminium with minor occurrence of calcium, magnesium and sodium with traces of titanium, iron and potassium (**Fig. 10b**).
