# Utilization of repair mortar for the loss compensation of Hungarian porous limestone

Keywords: repair mortar, limestone, binder/aggregate ratio, compressive strength, compatibility

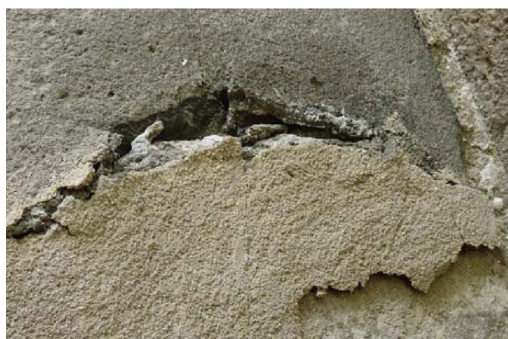
Fig. 1. Loss compensation with incompatible repair mortar.  
1. ábra Kőkiegészítés nem kompatibilis habarccsal.

Case studies have shown, that many of the commercially available (ready-mix) repair mortars can not be adequately used under certain conditions and are not compatible with porous limestone [17-18] (Fig. 1). Only limited data are available from the product properties in catalogues, safety data sheets, product specifications. There is not enough information about the porosity, fluid transport properties, pore-size distribution, long-term behaviour of the mortars and compatibility with porous limestones. Therefore, further information is needed to find the best performance and compatible mortar for the given stone. Repair mortars have been tested according to the European (EN) and American (ASTM) standards and performance in terms of strength, porosity, hydro-technical properties were measured [12-13].

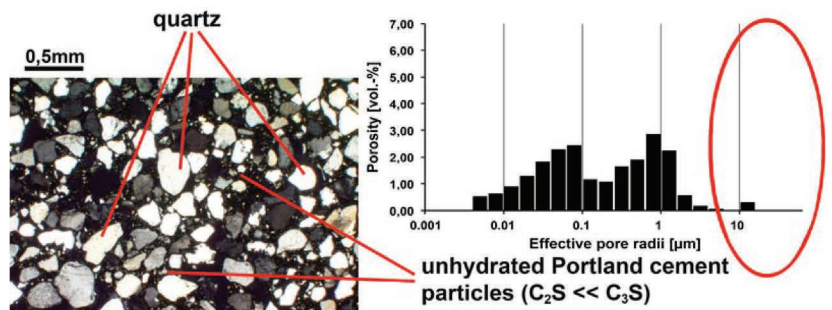
Fig. 4. Thin-section of the pure, commercial available repair mortar (M) with the histogram of the pore size distribution.

4. ábra Hazai kereskedelmi forgalomban kapható kökiegészítő habarcs vékonycsiszolata és póruseloszlásának histogramja.

**Mortars (M):** The binder is mostly calcitic, and the aggregate is mostly given by small rounded quartz grains of 10–500  $\mu\text{m}$ . The hydraulic binder content of the samples (white portland cement) is clearly demonstrated by the unhydrated cement particles. Hydrated alite ( $\text{C}_3\text{S}$  - mostly), and small amounts of belite ( $\text{C}_2\text{S}$ ) was also observed, furthermore a mixture of slaked lime was present in all of the four commercially available repair mortars (Figs. 4 to 6).

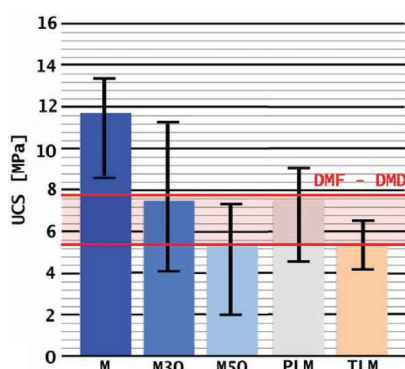
Fig. 7. Average value with the standard deviation of the compressive strength of the tested mortars. All the values measured for the limestones are shown in the zone indicated in red colour.

7. ábra Habarcsok átlagos egyirányú nyomószilárdsága és szórása. A piros sávban voltak mérhetőek a kétféle mészkővön a nyomószilárdsági értékek.

Pure repair mortars (without limestone sand aggregate) have more than double of the strength than that of the tested porous limestones. Added limestone sand aggregate can reduce the strength of the mortars and it becomes closer to the strength of limestone (Fig. 7 and Table 1).

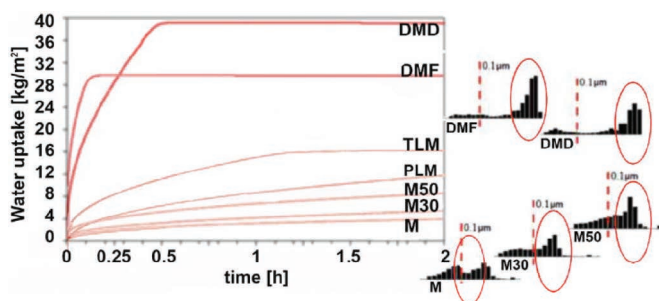
Fig. 8. Capillary water uptake in the tested materials with the pore size distribution (DMD-coarse limestone, DMF-fine limestone, M, PLM, TLM tested mortars).

8. ábra Kapilláris vízfelvétel a vizsgált anyagokban a pórusméret-eloszlással (DMD-durvaszemű durva mészkő, DMF-finomszemű durva mészkő, M, PLM, TLM habarcsok).

The capillary water uptake of the tested limestones is much faster than that of the tested repair mortars (Fig. 8). The slow water uptake of the pure repair mortars are proportionally increased, when limestone aggregate was added. The biggest increase in capillary water uptake was measured at mortars made with trass cement binder. Smaller increase was detected in water uptake at commercial available mortars with limestone aggregate (M30, M50).
