# Full-scale Fatigue and Burst Tests on Notched Pipeline Girth Welds, under Complex Loading Conditions

János Lukács\*, Ahmad Yasser Dakhel

Institute of Materials Science and Technology, Faculty of Mechanical Engineering and Informatics, University of Miskolc

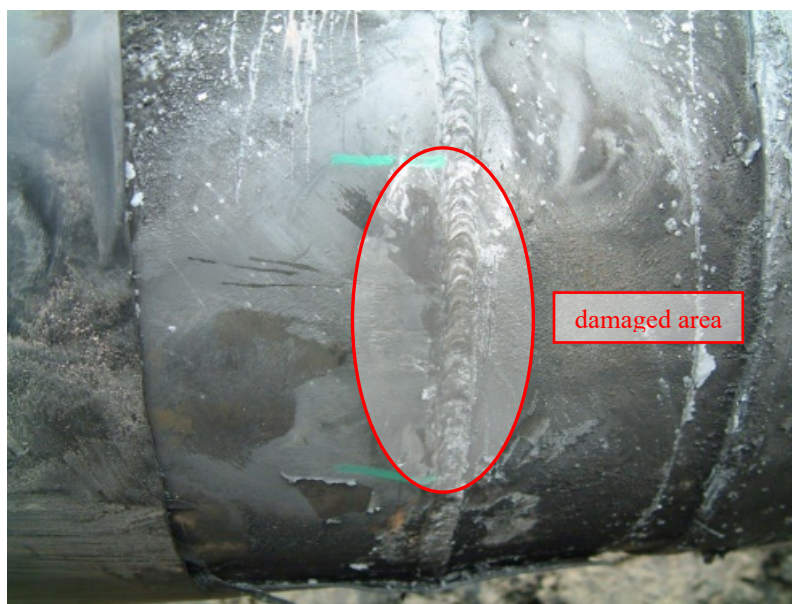
The damaged area of a girth weld on a Hungarian DN400 pipeline: crack in a repaired girth weld.  
Pipeline materials designation by API 5L: Grade B and X52

The following figures show three examples of damages on girth welds in Hungary. Figure 2 illustrates a DN400, Figure 3 a DN600, and Figure 4 a DN800 gas transmission pipeline girth weld damage.

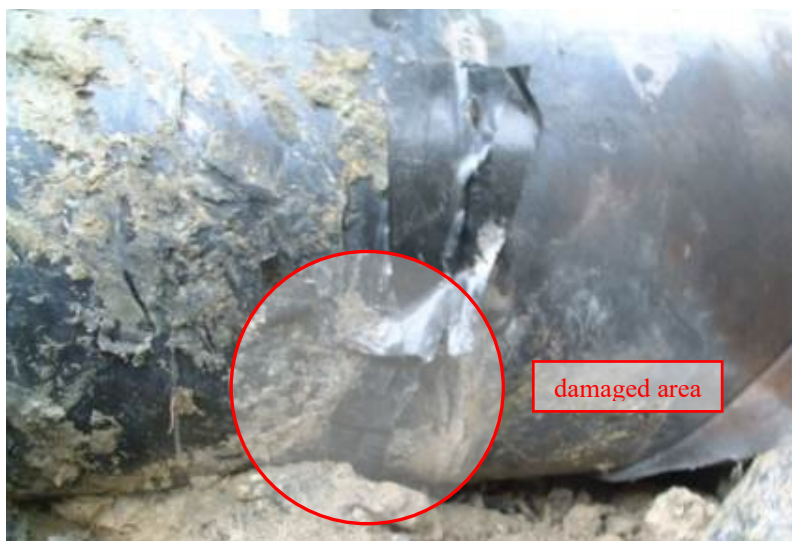
Figure 3

The damaged area of a girth weld on a Hungarian DN600 pipeline: crack caused by repair and unforeseen (not planned) cyclic loads. Pipeline materials designation by API 5L: X52 and X60

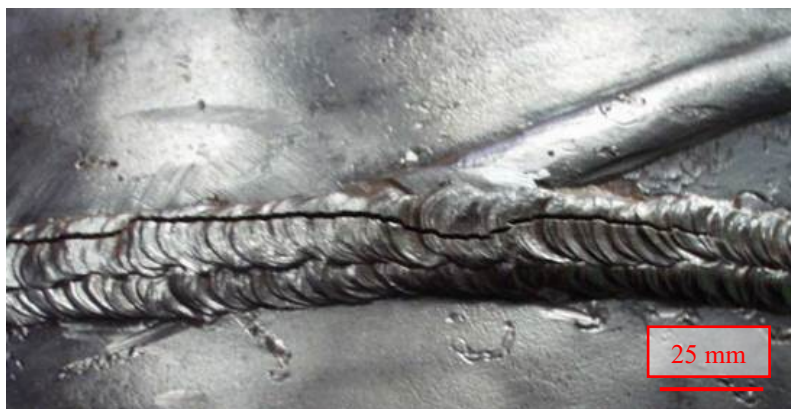
Figure 4

The damaged area of a girth weld on a Hungarian DN800 pipeline: crack caused by geometrical irregularities and unforeseen (not planned) cyclic loads, and initiated in the intersection point of a girth weld and spiral weld. Pipeline material designation by API 5L: X65

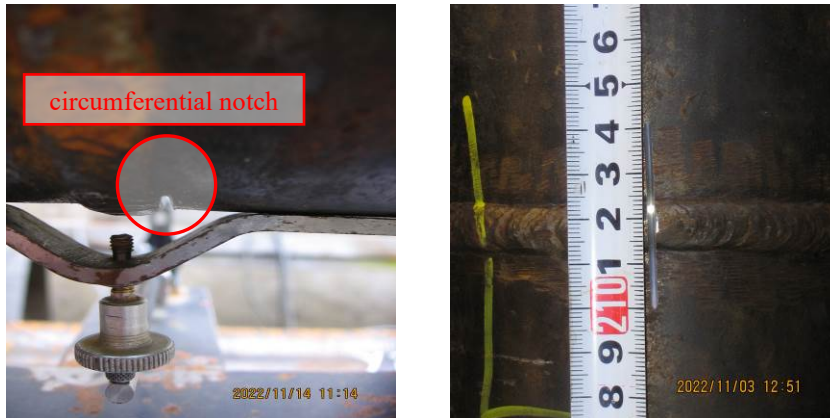
Figure 11 shows a notch in a girth weld HAZ (Y9 pipeline section) and through a girth weld (Y8 pipeline section) as examples.

Notch in the girth weld HAZ of the Y9 pipeline section (left) and through the girth weld of the Y8 pipeline section (right)

Five pipeline sections were tested, one of them without and four with artificial notches. The notches were cut using a hand grinding machine and located either in the heat-affected zone (HAZ) of the girth weld (circumferential direction) or through the girth weld (axial direction). Transporting pipeline operator experiences have shown that external undercuts and lack of fusions (between the base materials and weld metals) are common in poor quality girth welds. These defects were modelled using circumferential notches. Furthermore, transporting pipeline operator experiences have demonstrated the high incidence of longitudinal defects and their increased risk in welds (girth and spiral welds). The interaction of these defects with girth welds were modelled by longitudinal notches. Since the notches were made with the same hand grinder, their maximum nominal width was 2 mm. The shape of the notches followed the shape of the grinding wheel, with the width dimension narrowing slightly in the direction of depth (see left part of Figure 11).

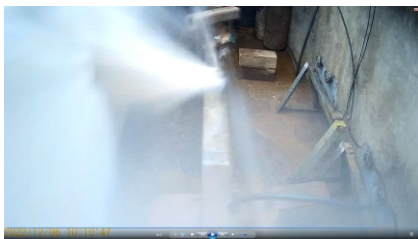
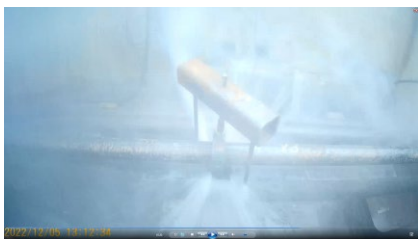
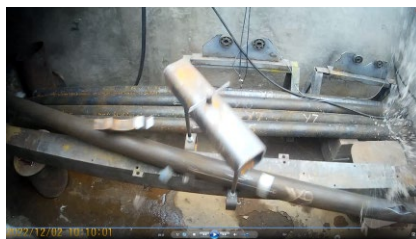
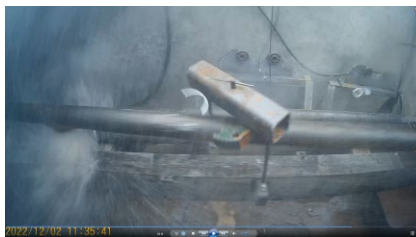
Figure 17

The investigated pipeline sections at the end of their burst tests, at the moment of their failures, can be seen in Figure 17. The details of the figure show same

characteristics, only the pipeline section containing the longitudinal notch remained in place until the end of the burst test.

The pipeline sections at the moment of their failures

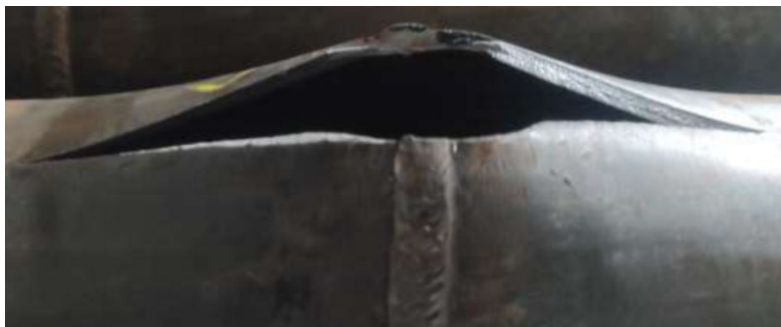
Figure 18 shows a closer look of the damaged area of the Y8 pipeline section.

The damaged area of the Y8 pipeline section after the fatigue and burst tests
