# Testing ChatGPT with Photovoltaic Electroluminescence Image Analysis

**Dávid Matusz Kalász\* and István Bodnár**

University of Miskolc, Institute of Physics and Electronics

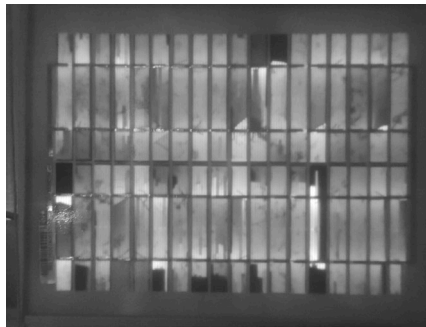
Figure 1

During the first conversation, we showed an EL image (Figure 1) that we made in a laboratory of the University of Miskolc with a modified Nikon Coolpix B700 digital camera. We then asked ChatGPT what it knew about PV electroluminescence.

EL image of an average defective PV panel

ChatGPT has broad knowledge in the field of PV electroluminescence. The AI already knew that the brighter areas suggest good material quality and uniformity (Figure 1), which generally indicate a well-functioning cell. However, it is important to perform a detailed analysis to confirm the absence of defects such as cracks, shunts, or other irregularities that could affect the cell's performance. The uniform brightness and the natural appearance of crystal grains without dark spots or irregular patterns are positive signs. In the EL image shown in Figure 1, dark regions typically correspond to areas where the cell is not emitting infrared radiation effectively, which can be due to several reasons:

In electroluminescence (EL) imaging of Figure 1, this kind of dark image typically indicates that the cell is not emitting any significant infrared radiation (inactive), which means it is not generating electricity effectively. There are several possible reasons for this:
