# Overload and Lifetime Test of Machine Cut Polymer Gears

**Abstract:** The weight of polymer gears is increasing continuously due to their advantageous properties. This is the reason why in recent years traditional metal gears have been replaced by polymer counterparts in plethora applications. Despite their benefits, their load-carrying capacity is limited. The polymer gears become unable to operate and their teeth generally fail when the load exceeds a defined limit. It is required to explore the limit of polymer materials in gear field. In this work, the gears are manufactured by machine cutting. This paper aims to investigate the limit of load-carrying capacity and the lifetime of POM and PA6 G gears.

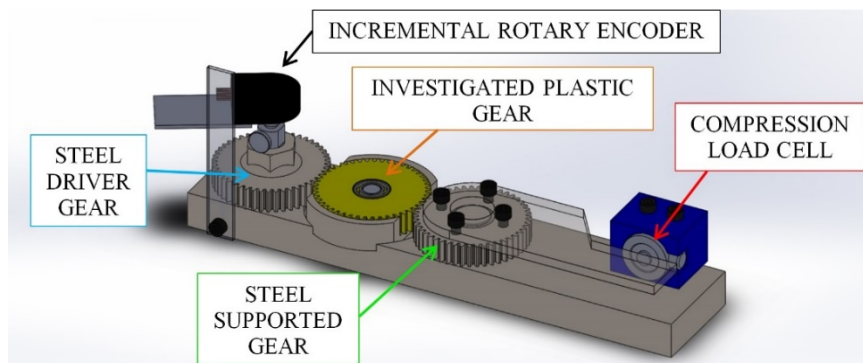
Figure 1. Test rig for overload test

A unique test rig, which was designed and manufactured at Szent István University, is used for one extreme case of failure to investigate the overload resulting from a combination of high load and low speed, where torque is continuously increased until fracture. The test rig simulates the situation when gear gets stuck. The test rig, as shown in Fig. 1, can investigate the load-carrying capacity of polymer gears and to continuously measure the torque and angular displacements of gears under dry-run conditions without wear by a load cell and an incremental rotary encoder, respectively.

It consists of three identical geometry gears and two sensors. Two of three gears, which are made from steel, are responsible for the transmission of the load because of its higher strength. The plastic gear, which aligns between the steel gears, are investigated. For a recording of values, an HBM Spider8 amplifier was used.

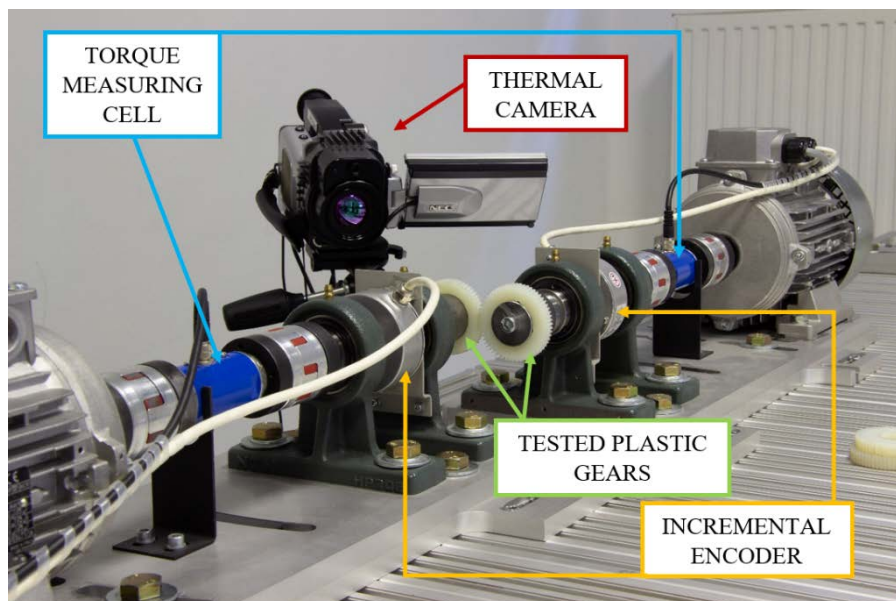
Figure 2. Test rig for lifetime test

For the investigation of fatigue failures, a test rig, as shown in Fig. 2, is usually used where the gears are loaded by predefined torque and speed. The main goals of these tests are to determine the tribological behaviours, the failure modes, and the temperature behaviour of a plastic gear pair under dry-run conditions. The test rig is used for an overloaded condition to investigate the lifetime of the gears due to a combination of high load and high speed. In all cases, the tests last until the gears fail.

The test rig is made up of several components. These components are stand, motor units, electrical and measuring systems, and accessories. To measure speed, angular velocity fluctuations, angular deviations between axes, angular accelerations, the

test rig is equipped with incremental encoders with a resolution of 5,000 pulses per revolution. Torque values are recorded by two torque measuring cells with a measuring range of 0 to 17.5 Nm. For a recording of the required parameters, an HBM Spider8 data acquisition system was used [12].

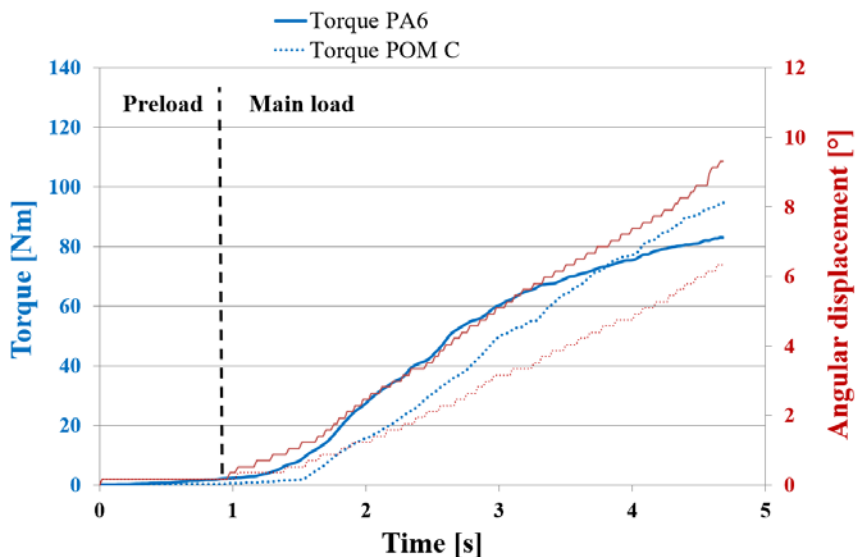
Figure 3. Characteristic curve of PA6 and POM gear in overloaded test

A characteristic curve is shown about the typical load capacity of the PA6 and POM gears in Fig. 3, where the values of torque and angular displacement appear as a function of time. The fracture of the teeth of PA6 gears occurred under a load of

83 Nm and angular displacement of  $9.3^\circ$ . The teeth of POM gears have more load carrying capacity, because their failure occurred at a load of 94.7 Nm and when the gear rotated approximately  $6.3^\circ$ .

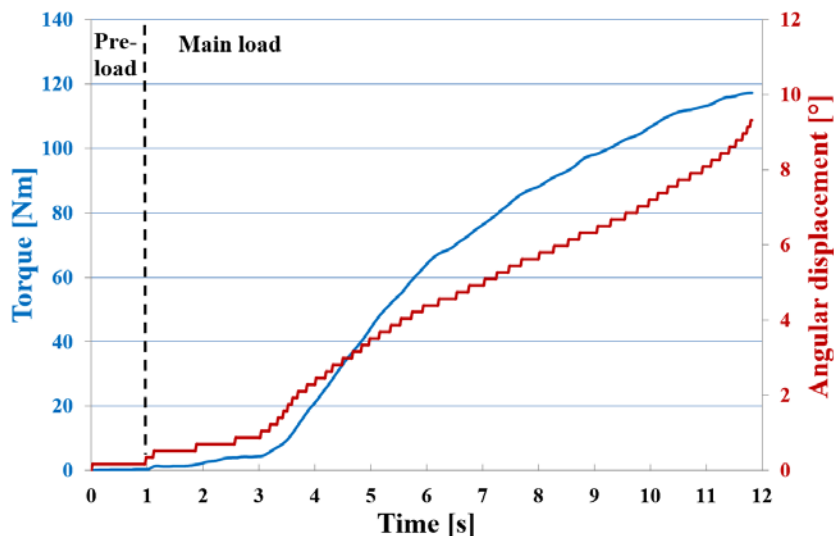
Figure 4. An overloaded test of PA6 gear with lower stress rate

It can be seen in Fig. 4., the speed of the initial load and then the main load changes during the measurement, so the angular displacement is not constant during the time unit. It is also clear that a kind of hardening occurs, when the speed of load starts to increase, the material responds with hardening, like a tensile test. It is known from fracture mechanics that the stress rate plays a particularly important role in the tough and brittle behaviour of materials. The teeth of the PA6 gear were broken at an angular displacement of  $9.3^\circ$  and a torque of 117.2 Nm. The deformation stayed the same, however, the material had time to deform, so it showed more toughness and had a higher load capacity.

The torque and the angular displacement are related pairs for gear tests, and their relationship is crucial. It is important how the torque changes in view of the angular displacement. Therefore, a supplementary test with a lower speed of a load was carried out with cast PA 6 gears.

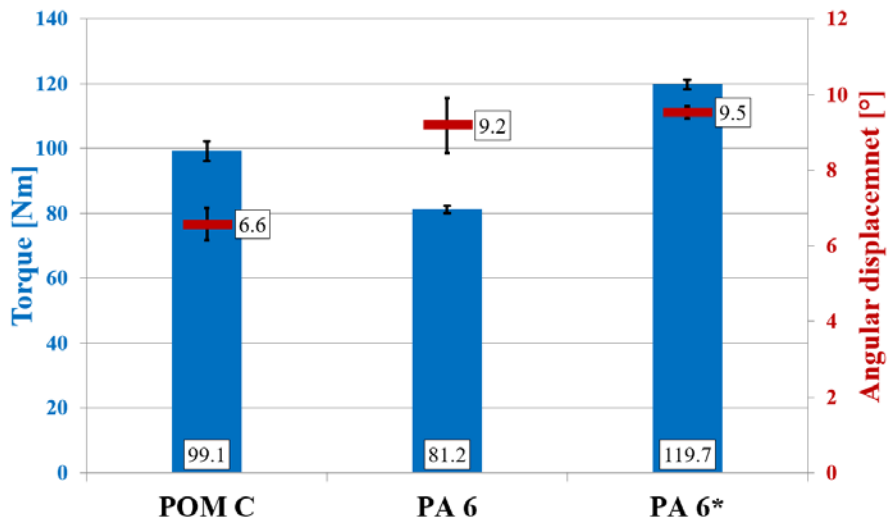
Figure 5. The main results of overloaded tests

The aggregate results of overloaded tests are shown in Fig. 5. PA 6 gears failed at an average load of 81.2 Nm and angular displacement of 9,2°, while POM gears failed at 99.1 Nm and a rotation of 6,6°. The PA 6 gears tested at lower load speed failed at an average load of 119.7 Nm and angular displacement of 9,5°. The obtained deformation results are supported by the literature as well as the datasheets of the plastics company for both materials. The elongation at break of PA 6 is 130%, while that of POM C is only 32%, i.e. approximately a quarter. This can also be seen in the deformation measured in angular displacement. The teeth of the PA 6 wheels withstood about 140% more deformation at the time of fracture than the POM C wheels. Surprisingly, POM C gears were failed at an average load of 122% higher than PA 6 gears. This is unexpected because POM C has a lower yield point than PA 6. This fact is pointed out that the yield strength of the material is not sufficient to assess the tooth failure of plastic gears. Additional material properties such as fatigue limit, surface adhesion, the combined effect of heat conduction can override the importance of strength.

The results of a supplementary test at a lower stress rate have indicated that if the performance is the same, i.e. the product of torque and angular velocity is constant, but their proportions are different, then the failure process will be different. At the PA 6 gears, the material behaved more brittle due to the higher speed of load, as it did not have enough time to deform.

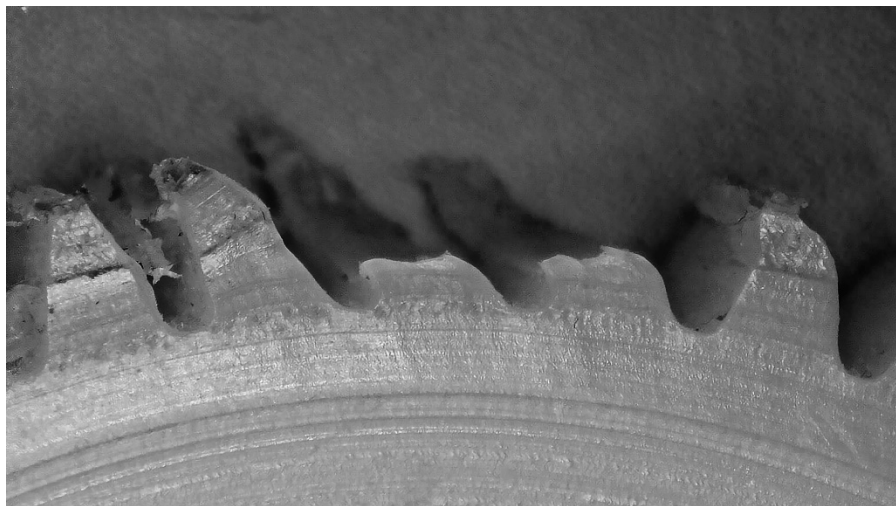
*Figure 6. The fractured teeth of a PA6 gear*

There is a microscopic image of a broken PA6 gear to analyse the fracture in more detail (see in Fig.6). It can be seen that their teeth were strongly deformed, underwent a permanent deformation, and the loaded teeth fractured below the pitch circle. In most cases, two teeth are broken off completely. During meshing, not only two teeth were loaded, however, the nonfractured teeth also suffered non-recoverable deflection.

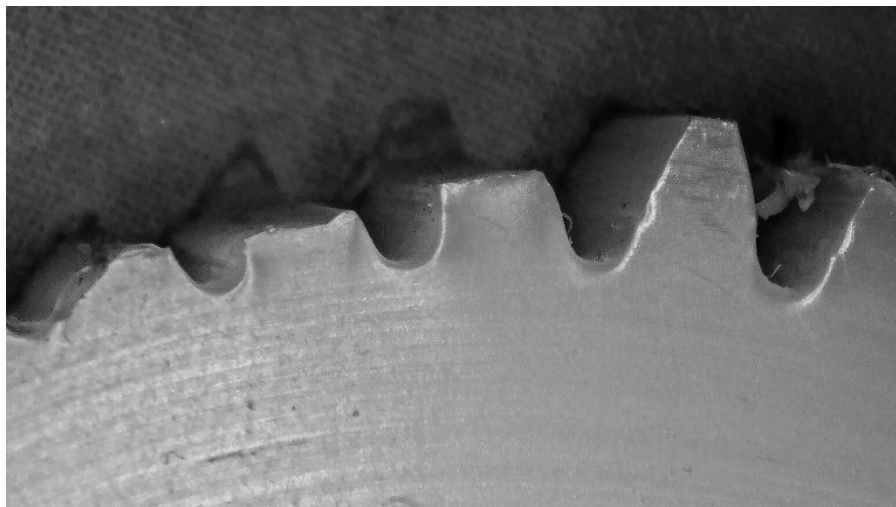
*Figure 7. The fractured teeth of a POM gear*

A microscopic image is shown about the failure of a POM C gear in Fig. 7. Their teeth behaved more brittle than PA6 because three of their teeth broke approximately along a straight line, the fracture surfaces were even. There is no significant sign of deformation at these gears.

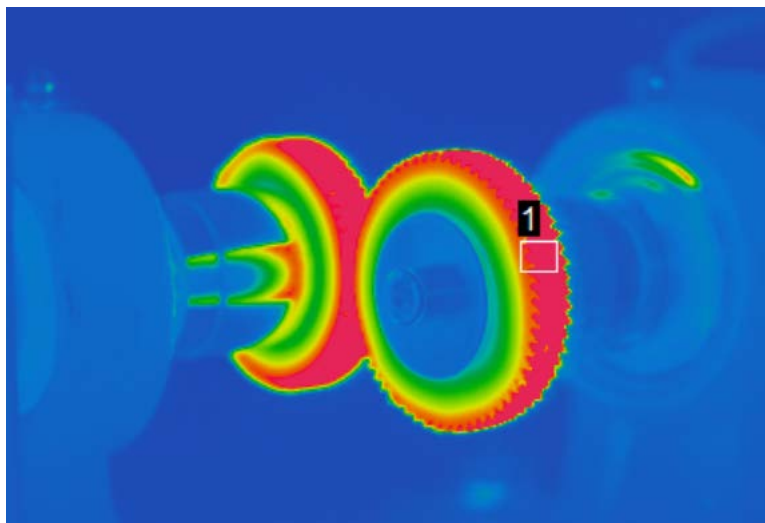
Figure 8. Thermal image of PA6 gears with sampling area

The lifetime test is capable of investigating how long the plastic gears can operate or how the temperature of the gear changes under this extreme condition. During the test, the temperature was measured by a thermal camera, as shown in Fig. 8. For plastic gear, the heating causes serious problems because the mechanical properties of the material deteriorate with increasing temperature.

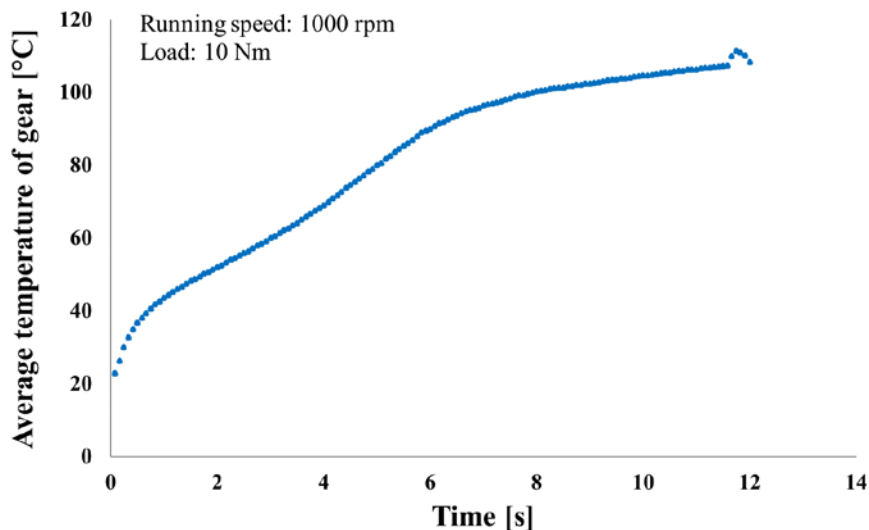
Figure 9. The heating of a PA6 gear

The rise of the average temperature of a PA6 gear is demonstrated in Fig. 9. For the given gear geometry, the running time was approximately 12 minutes, which corresponds to 12,000 cycles (revolutions). During the time from start-up to failure, the average temperature change of the gear surface is 88.5 °C. Starting from room temperature (23 °C), the surface of the tooth could reach 100-110 °C, while the environment of the tooth could reach 80-90 °C. In the air, for long-term use, the cast PA 6 can be used safely up to 105 °C according to the manufacturer's data [11]. So, at such a high temperature, the strength of PA 6 deteriorated strongly, such as the

yield strength, which decreases by a quarter at 100 °C, or the modulus of elasticity, which decreases by a third at the same temperature. The temperature change measured on the tooth surface is also confirmed by the data in the literature [13]. All data are mean values of at least two repetitions.

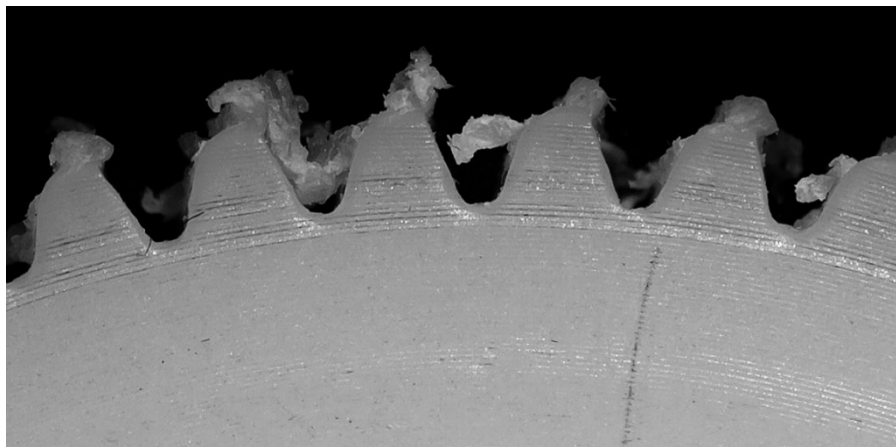
*Figure 10. The melting of the teeth of a PA6 gear*

The failure of gear at constant high load and high speed is indicated in Fig. 10. The teeth of a PA6 gear suffered permanent deformation. Softening or melting of the teeth can be recognized. There was no breakage of the teeth, however, strong wear was observed at the tip of the teeth. The malfunction occurred abruptly after 12,000 cycles. As a result of the melting of the gear, the tooth meshing discontinued.

It can be clear that the heat generated, and its dissipation plays a particularly important role in polymer gears. Using oil or water as a lubricant can multiply its lifetime.
