# STABILITY ANALYSIS OF UNFAVOURABLE GEOLOGICAL BODIES IN A POST-EARTHQUAKE AREA: A CASE STUDY IN GENGDA TOWNSHIP CHINA

**Abstract.** On 12 May 2008, a devastating mega-earthquake of magnitude 8.0 struck the Wenchuan area, northwestern Sichuan Province, China. Following this earthquake event, many areas in the affected areas were susceptible to geological disasters, such as debris flows, landslides and other secondary disasters. To better understand the mechanism of the formation processes of geological disasters, and to reduce the economic loss caused by the disasters, a comprehensive analysis is required. With the aim of obtaining the characteristics of unfavourable geological bodies, and analysing their stability, we choose the Gengda Township as an example (there are many unfavourable geological bodies distributed in this area, including landslides and deformation bodies). Field investigations and computational models are employed to analyse the stability of the unfavourable geological bodies. Through preliminary analysis and model calculation, the following conclusions can be drawn: under natural conditions, the stability factor of the landslide ranges from about 1.02–1.03, w

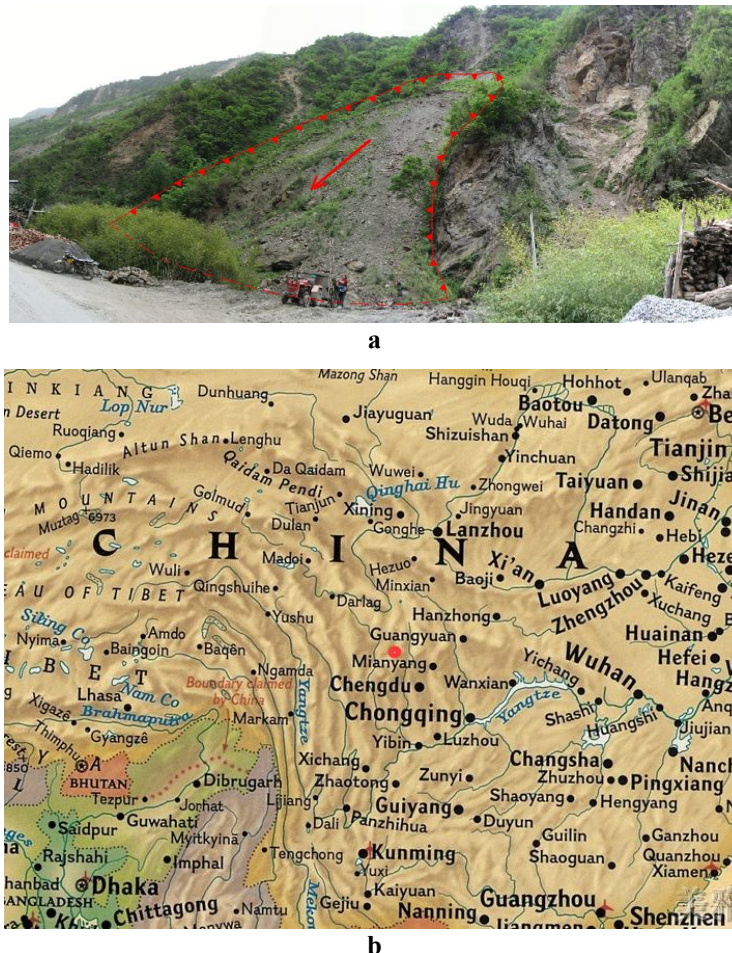
**Figure 1.** Full view of Nitianguo landslide (red point is the study area). **a** Landslide range, **b** location of the study area

The field investigations were conducted from the period between June 2009 and July 2009, and these work lasted for around one month. Our investigations are primarily concentrate in Gengda township, Wenchuan prefecture, Sichuan Province. During the processes of investigations, we mainly collected the data with regard to rainfall conditions, geological conditions, topography, etc. The main purpose of the field investigations concerned the following main issues: an initial consideration of the distribution, scale, geological conditions, and triggering factors of each unstable body, followed by a preliminary analysis of the formation mechanism of each unstable body alongside an evaluation of its stability. These results can be compared with subsequent model computations, which can help us to draw reasonable and accurate conclusions. These conclusions can provide a reliable geological basis for designing preventative engineering measures for each unstable body. With the help of Wolong Reserve Management Bureau, Wolong Land Resources Bureau, and Wolong township government, field investigations were conducted and lasted for around one month. The scope of the investigations not only concentrated on the unstable body itself but also included the adjacent zone (within a 20 metre radius) and the area susceptible to these unstable bodies. Through the field investigations, it was possible to acquire the fundamental data of the study area, which are described in the following sections.

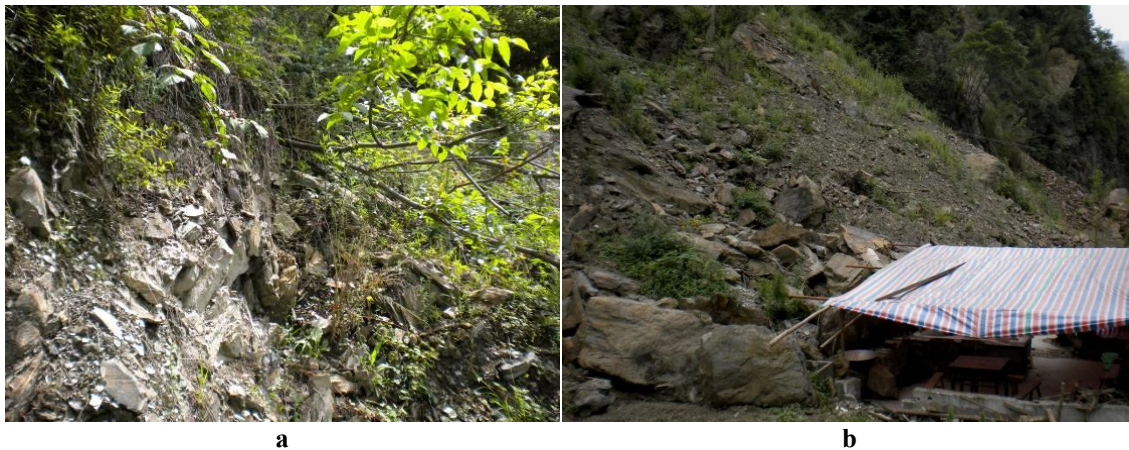
**Figure 2.** Other types of unstable geological bodies. **a** Collapses , **b** unstable slopes

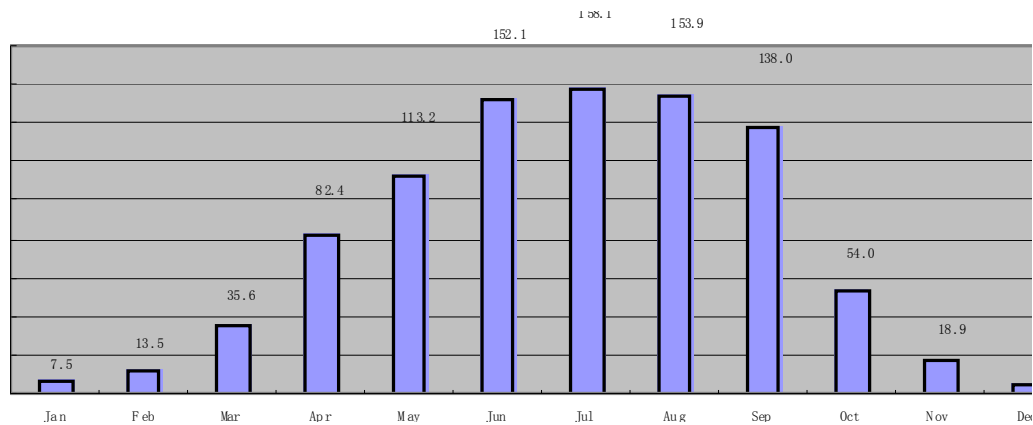
**Figure 4.** Histogram of historical average rainfall (mm)

Climatically, the study area falls into the subtropical humid climate zone; during winter the area is significantly affected by the Qinghai-Tibet Plateau climate, while in summer it is mainly dominated by the southwest and southeast monsoon climate. The mean annual precipitation is 930.2 mm, and the rainfall is mainly concentrated during the period from May to September, which contributes more than 78% of the total precipitation throughout the year. According to the rainfall contour diagram of Sichuan province illustrated in the manual of flood calculations for small and medium-sized basins, the rainfall data for 10 min and 1, 6, and 24 h can be acquired and the corresponding amounts are 10, 20, 65, and 120 mm, respectively. Some slopes in the study area have been loosened by the effect of seismic activity, which will result in instability under subsequent heavy rainfall conditions (Tang et al., 2011). The rainfall data from 2000 to 2009 were gathered, as shown in *Table 2*, and the historical rainfall histogram is shown in *Figure 4*.

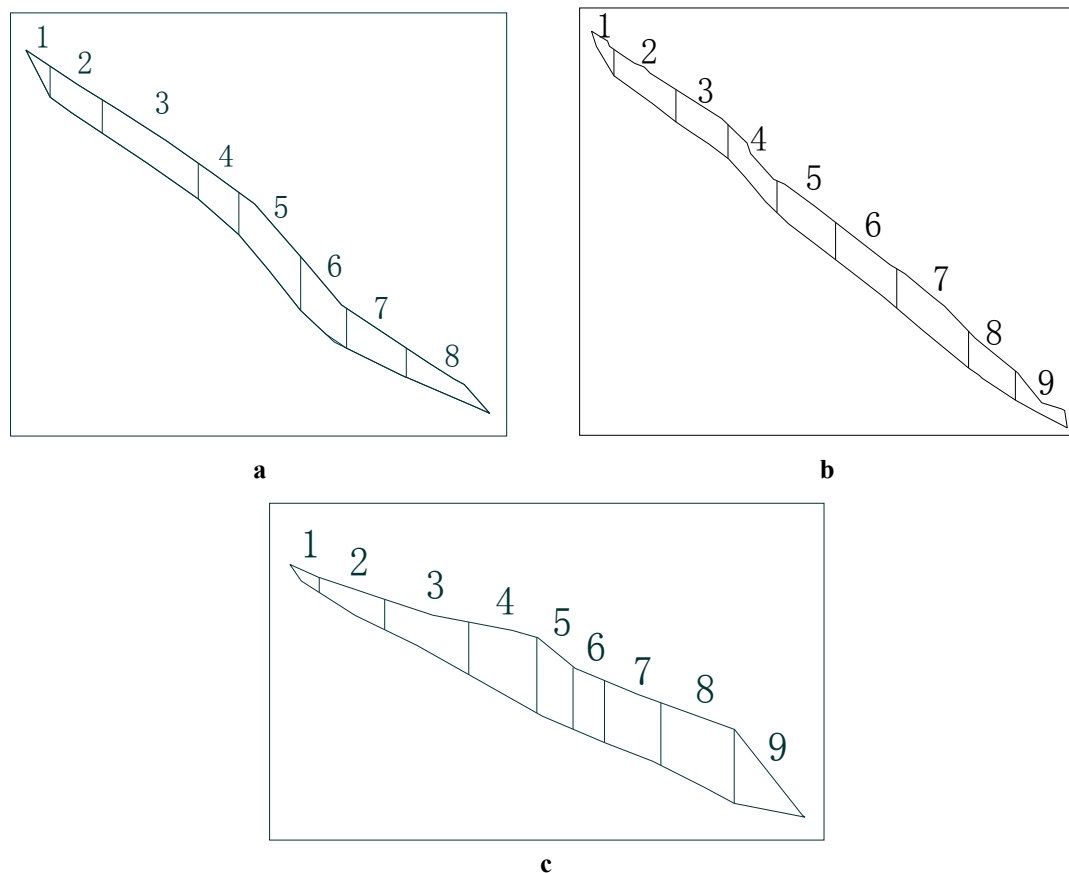
**Figure 5.** Stability calculation diagram of **a** strip 1 of No 1 deformation body (profile); **b** strip 2 of No 1 deformation body (profile) and **c** strip 5 of No 2 deformation body (profile)

According to the principle of the Transfer Coefficient Method, the unfavourable bodies in the study area can be vertically divided into several strips. Through preliminary analysis, we found that strips 6 and 7 are the most dangerous sliding bodies in the whole landslide, strips 1 and 2 are the most dangerous sliding bodies in No 1 deformation body, and strip 5 is the most dangerous body in No 2 deformation body. The stability calculation diagrams are shown in *Figure 5a-c*.

On the basis of Section 4, the calculation can be conducted and the calculation results can be obtained. Then the safety factors of strips 6 and 7 of the landslide, strips 1 and 2 of No 1 deformation body and strip 5 of No 2 deformation body can be obtained under different load conditions, as shown in *Table 4*. For No 1 deformation body, under the influence of the own weight of sliding body, the safety factor is 1.04, and under the effects of the own weight of sliding body and rainfall (34 mm/h), the safety factor is 1.03, results of the analysis can also be applied to landslide and No 2 deformation body.
