## THE RIVERINE FLOOD CATASTROPHE IN AUGUST 2010 IN SOUTH PUNJAB, PAKISTAN: POTENTIAL CAUSES, EXTENT AND DAMAGE ASSESSMENT

**Abstract.** The paper investigates the causes, magnitude and damage caused by the flood as a result of the breaching of the east marginal embankment of the Taunsa Barrage. The flood frequency in the district of Muzaffar Garh located in south Punjab, Pakistan had serious impacts on human lives and their properties. To pursue this study, we used primary data, collected through questionnaire, formal interviews, field observations and secondary data, obtained through government departments and online open source databases. Furthermore, Landsat ETM+ imageries were used as input in the supervised classification in order to investigate the pre and post flooding land cover and land use. Hydrograph was used to analyze the flood limits and spatiotemporal change in river discharge for barrages. The results show an abnormal rainfall occurring in the month of July in the upper Indus Basin, which resulted in a massive discharge in the central Indus Basin. As a consequence, it exceeded the flood limits at the Taunsa Barrage, which resulted in the breaching of east marginal

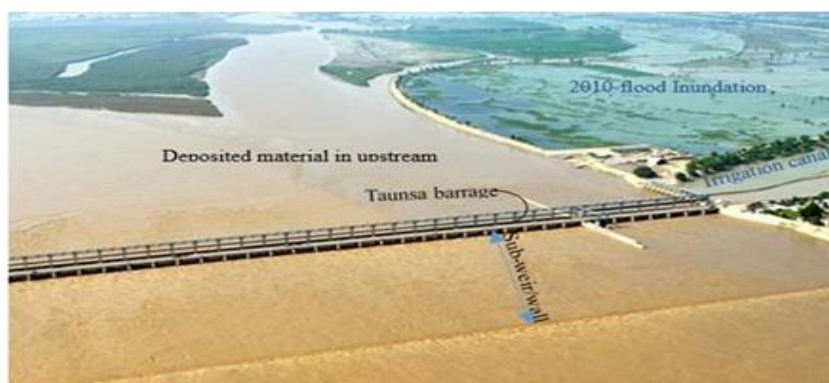
**Figure 5.** Aerial view of the Taunsa Barrage, construction of sub-weir, sediments in head up during the flood in 2010. (Source URL: <https://www.dawn.com/news/1195398>)

Taunsa Barrage is located in south Punjab district Muzaffargarh (Fig. 2). Taunsa Barrage is considered the most susceptible barrage structures built across the River Indus (Chaudary and Sarwar, 2016). As Figure 5 shows in the year 2008, for the purpose of diversion structure re-modelling the construction of a sub-weir was completed at Taunsa Barrage which had about 2.5 m vertical and 274 m horizontal length. For this construction work, a massive coffer dam was used. Consequently, after completing the construction work, the coffer dam discarded material remained at the top of sub weir caused a minor blockage at the downstream of the Taunsa Barrage (Chaudary and Sarwar, 2014). As a result, flood-2010 water level remained the same in the upstream and downstream of the barrage. Similarly, the rising riverbed resulted in the deposition of large amount of sediments downstream in head up area that has reduced the discharge capacity of the Taunsa Barrage and triggered the high waves of flood water back to its embankment on the eastern side and breached the protection EM embankment (Fig. 6).

The flood 2010 occurred in the study area following the worst weather forecast ever recorded in history by Pakistan meteorological stations in the month of July 2010, with respect to cloud formation incorporated with spatial extent and duration of monsoon rainfall, as a result of the convergence of monsoon winds with upper air jet stream over the North-western regions of KPK province, Pakistan (PMD, 2010; Rehman and Khan, 2013; Mahmood et al., 2016a, b). As *Figure 4* shows the evidence of high rainfall of more than 250 mm recorded during 2010 in comparison with last decade rainfall data that triggered the high inflow of 27184 m<sup>3</sup>/s at Taunsa Barrage. This high inflow was somehow equal to the designed capacity of the barrage as shown in *Figure 3*. Despite that the water flow was crossing at an alarming level, no action was timely taken to decide the breaching section at emergency purpose. In addition to this, as *Figure 5* shows that the influence of sub-weir construction and its upstream narrowing embankments certainly decreased the designed carrying capacity of the Taunsa Barrage. Furthermore, the Indus is famous for carrying a high sediment load from the Himalayas foothills and Taunsa Barrage structure has stuck huge sediments within the river belt thus causing the river bed raise in the last few years. Moreover, in the years 2004-2008, with the request of the Government of Pakistan (GOP), the World Bank took initiative and provided 144 Million US\$ for the remodelling of a diversion structure at Taunsa Barrage (Chaudary and Sarwar, 2014). They did the remodelling of the structure in such a way that they had constructed a sub-weir of about 2.5 m vertical and 274 m horizontal length downstream of the Taunsa Barrage, as shown in *Figure 5*. The coffer dam material was used for construction work. The coffer dam discarded material remained at

the top of sub-weir resulted in a minor blockage and an increased sediment in the river bed eventually resulted in the breach of the EM embankment.
