## STUDY REGARDING THE IMPACT OF WASTE LANDFILLS ON SURFACE WATERS

DAN-VLAD JAȘCĂU<sup>1</sup>, ELENA MARIA PICĂ<sup>1</sup>

<sup>1</sup>Technical University of Cluj-Napoca, Faculty of Materials and Environmental Engineering, 103 - 105, Muncii Blvd, 400641, Cluj-Napoca, Romania  
[dan\\_jdv@yahoo.com](mailto:dan_jdv@yahoo.com)

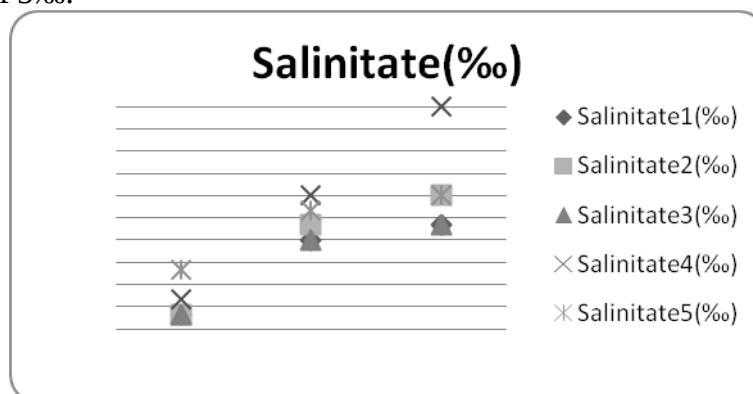
Figure 7. Representation of the salinity in Zapodie river

The water salinity as shown in *Figure 7* gets to approximately 1.7‰ in prelevation point P1, a high concentration compared to the values of maximum allowed concentrations (MAC) of 0.2‰, exceeding the maximum allowed values 8.5 times. In prelevation point P2, downstream from Pata Rat non-ecological waste landfill, an increase of the salinity concentration up to 2.4‰ can be seen, exceeding the MAC values 12 times.

The prelevation point P3 located downstream from the ecological hazardous waste landfill, belonging to the Terapia factory, doesnot have a significant contribution to the salinity of the water. In this prelevation point, the values obtained donot exceed the values in

prelevation point P2, except for the result of the analysed “Salinity 4” sample, that gets to a concentration of 3‰.
