## NATURAL HAZARDS IN SAO VICENTE (CABO VERDE)

### Abstract

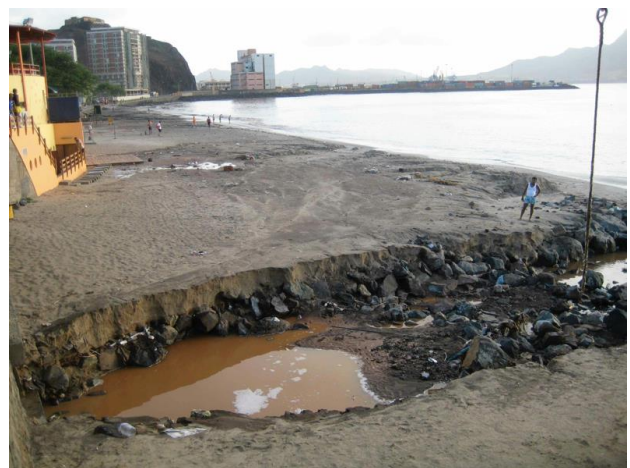
Fig. 3 Terminal sector of a stream on Laginha beach. Note the orange tonality and the materials deposited at the outflow of the stream

Periods of intense and concentrated precipitation contribute towards the significant loss of soil and generate powerful torrents due to the steep slopes that are filled with small materials, as a result of the poor vegetation cover (Fig. 2), which lend particularly active dynamics to the water courses. It is a common sight in São Vicente to see these streams reaching the sea loaded with solids, giving the water a yellowish-red tonality, principally near the outflow of the streams (Fig. 3).

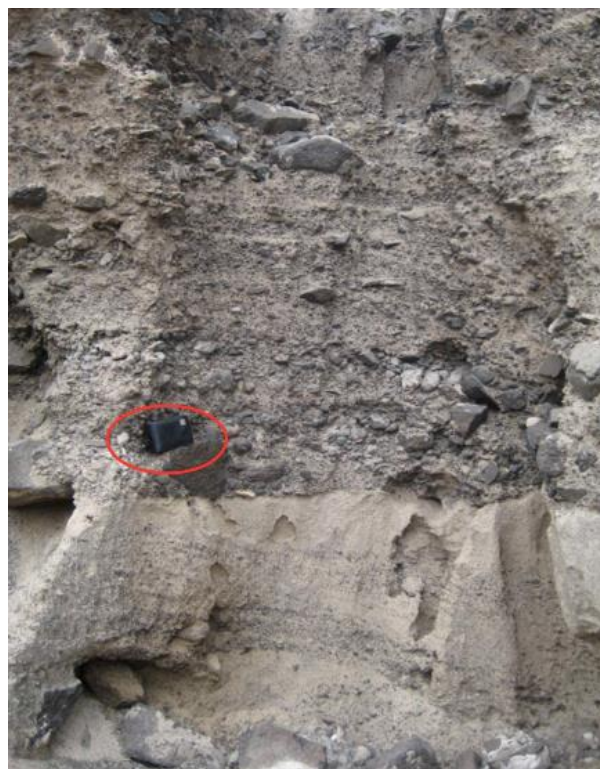
Fig. 5 Typical profile where we see colluvium and lower down wind-blown deposit. The box of the camera surrounded by the circle serves as a scale

well conserved (W1). The rocks generally have a disorganised disposition, especially the larger ones. Occasionally we observe interwoven stratification. The larger rocks are over one meter in diameter, with a great deal of heterogeneity regarding the degree of rolling, some with rounded edges, indicating that they were transported and subsequently deposited. Usually occupy a higher position to wind-blown deposit from the stratigraphic point of view (Fig. 5).

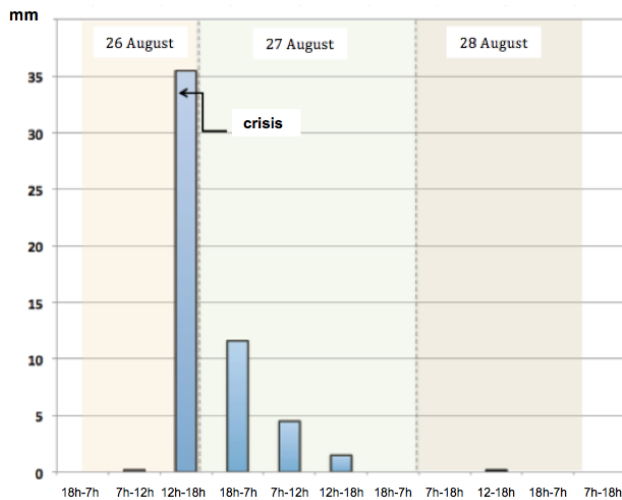
Fig. 8 Precipitation distribution (mm), in different intervals, in the weather station of the city of Mindelo, on 26 and 27 August 2008. Data source: INMG-CV

The flash flooding on 26 August 2008 caused enormous material loss. Rainfall amounts in the form of showers were over 35mm (Fig. 8). This was an episode of rainfall associated with two cells of low pressure, with greater incidence in the region south of Cabo Verde, which led to the development of convective cloud formation namely cumulonimbus (Cb). Levels of humidity of over 85% were recorded in the whole of Western Africa and strong nuclei of vorticity and well defined cyclonic circulation. There was also a tropical wave on the east Atlantic (precisely southwest of the archipelago), moving in a north-easterly direction, and the positioning of the intertropical convergence zone (ITCZ) along an alignment defined by the coordinates 07°N52°W/9°N34°W/16°N25°W and with disperse convection in its central axis (information obtained from the National Meteorology and Geophysics Institute of Cabo Verde).

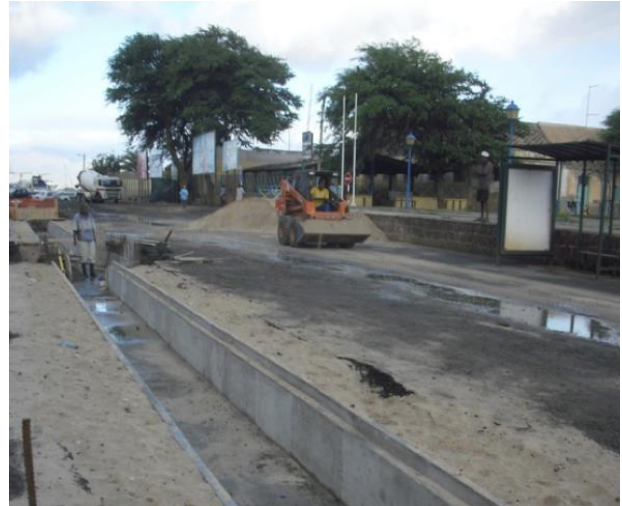
Fig. 9 Torrential correction works near Praça Estrela in December 2010

In order to mitigate the effects of flash flooding hazard, in December 2010, the Town Hall of São Vicente carried out some torrential correction works, one of the main ones being the construction of dikes in the upper reaches of the water courses and drainage channels in the Rua do Côco and near Praça Estrela (Fig. 9). While these works are considered to be effective in hazard mitigation, rainfall crises continue to occur in various areas of the city of Mindelo, as was the case of the flash flooding in September 2013 (Fig. 10).

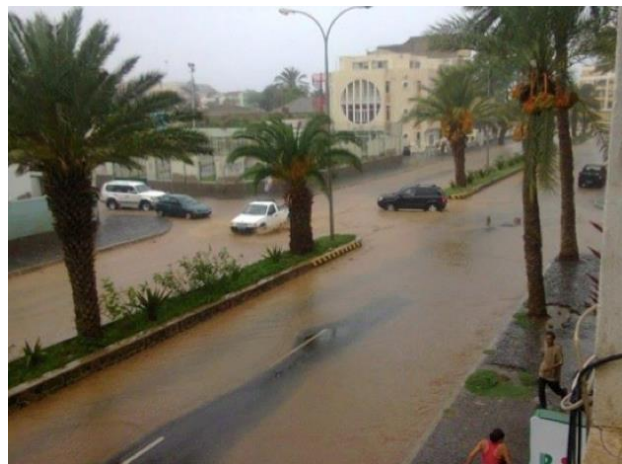
Fig. 10 The flooding of the Rua do Côco in September 2013

The losses were only material, but they showed that the drainage system is still insufficient. On the other hand, for the same intensity of rain we see that the flash flooding hazards have unfortunately increased.
