CONDITION ASSESSMENT OF SUBSURFACE DRAINED AREAS AND INVESTIGATION OF THEIR OPERATIONAL EFFICIENCY BY FIELD INSPECTION AND REMOTE SENSING METHODS

Keywords: soil moisture regulation, tile drainage, condition assessment, GIS

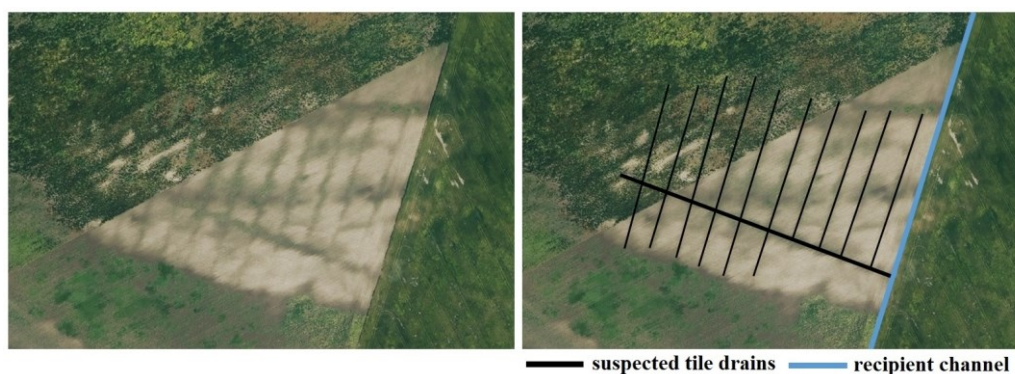
Fig. 4 Appearance of tile drain lines near Kunszentmárton, Hungary. The drawn lines on the bare soil continue on the surface with vegetation too, where the lines still could be observed due to differences in vegetation growth or species composition (source: Institute of Geodesy, Cartography and Remote Sensing of Hungary)

In general, after a precipitation event, the wet and drier parts of the study sites were easily separable in the case of bare soil surface. Contrary to our expectations we could not observe linear traces on UAV images suggesting the presence of drains at Mezőtúr study site. We observed drain lines only on the examined orthophotos (Institute of Geodesy, Cartography and Remote Sensing of Hungary) e.g. around Kunszentmárton, Hungary (Fig. 4).
