CONSTRUCTION OF RESIDENTIAL BUILDINGS ON COLUMNS AS AN ALTERNATIVE TO CONSTRUCTION IN AREAS EXPOSED TO FLOODS

DOMEN KUŠAR¹ AND MATEJA VOIGEMUT²

Abstract: *Floods that have in recent years become a constant in developed areas are raising the issue of how to adapt to nature when constructing housing. The construction of retarding basins and high dikes are the most frequently used alternatives of protecting the urban environment. Such a practice is most commonly found in Europe where it however, has unfortunately shown itself on several times, not to be the most effective. People from North America who live in areas often affected by floods, build their housing on columns. In Slovenia, not much thought is given to this, which is probably the result of the traditional mentality that promotes the building of massive residential houses and the issue of structural engineering that involves the so-called soft ground floor. New materials and new structural principles make construction on columns possible, which has been proven by the example of the residential building on low bearing soil in the seismic and flood risk area of the Ljubljana Marshes.*

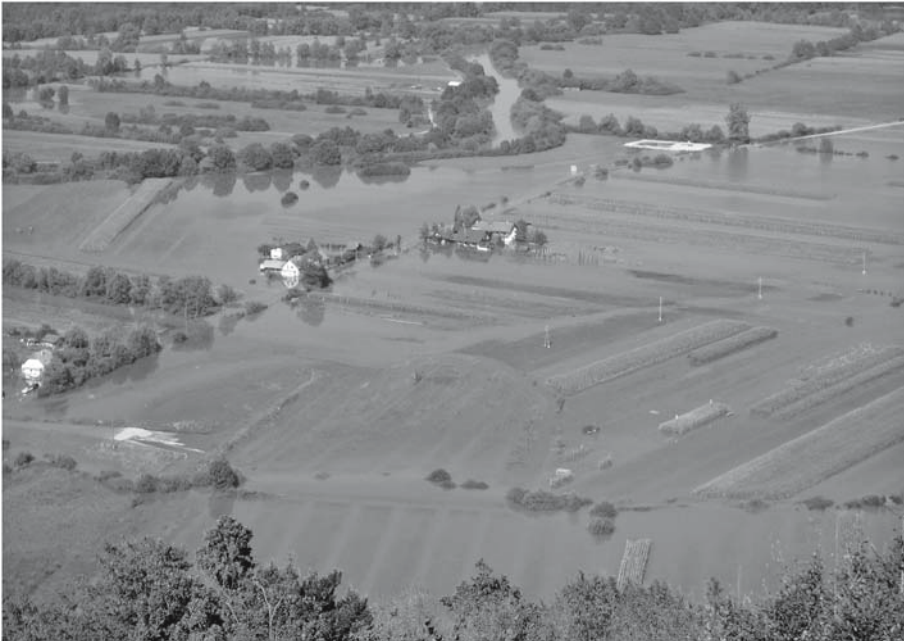
Figure 1. A lowland flood.

The other type of damage occurs during the lowland flooding of larger rivers, the sea, etc. For these types of floods, the response to precipitation is slow (several hours or even days), helped by successful weather forecasting providing adequate warning of the impending dangers. Typical for this type of flood is that the water rises slowly and has no special force. But usually such a flood lasts longer, because the outflow of the water is also slow (Figure 1).

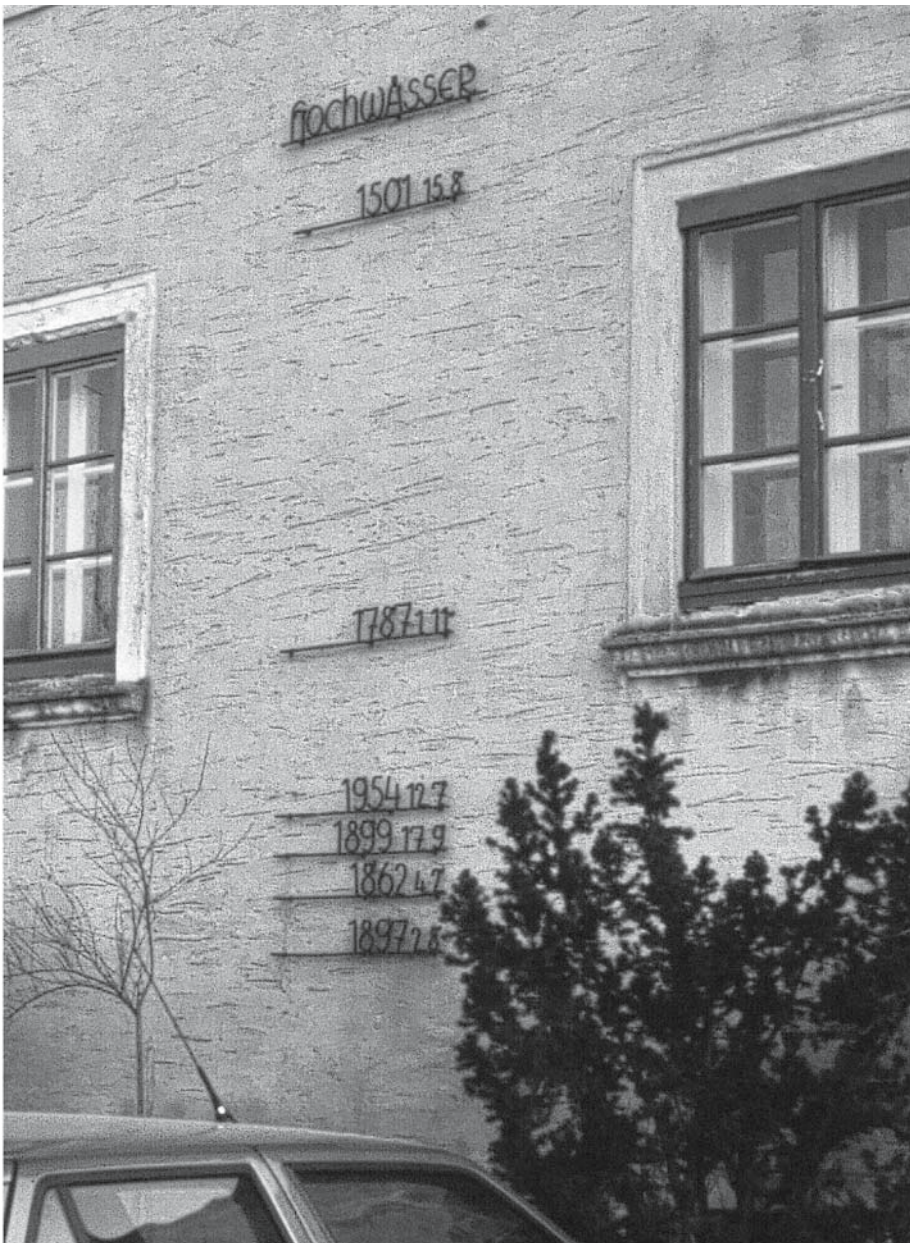
Figure 2. Markings of the high water level in Melk on the Danube.

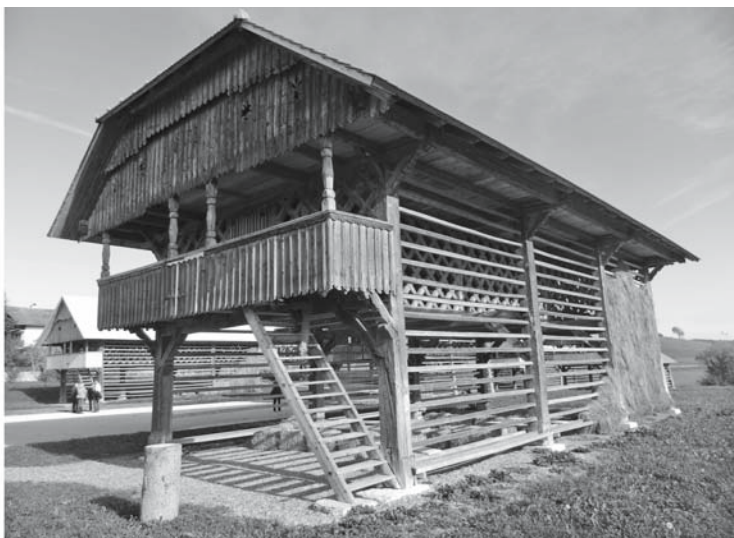
Figure 6. Kozolec (hayrack).

In Slovenia and the wider neighbouring region, construction on columns is not conventional, which is the result of a natural, social, economic and technological situation. Maybe our only indigenous buildings on columns are “kozolci” (hayracks) which are entirely made of wood and are intended for drying and storing hay (Figure 6). Due to this chosen method of storing hay they are made on columns that at the same time serve as part of the drying structure. In residential buildings this method of construction was not used. Due to fire hazards, wooden residential buildings in the past acquired a bad reputation. Only masonry buildings were deemed to be good buildings. Also due to the substantial weight and lack of technology at the time, such buildings could not be built on columns. Instead, people avoided flood risk areas and built their dwellings where the lowlands merged into the hill slopes, and not on the plain itself.

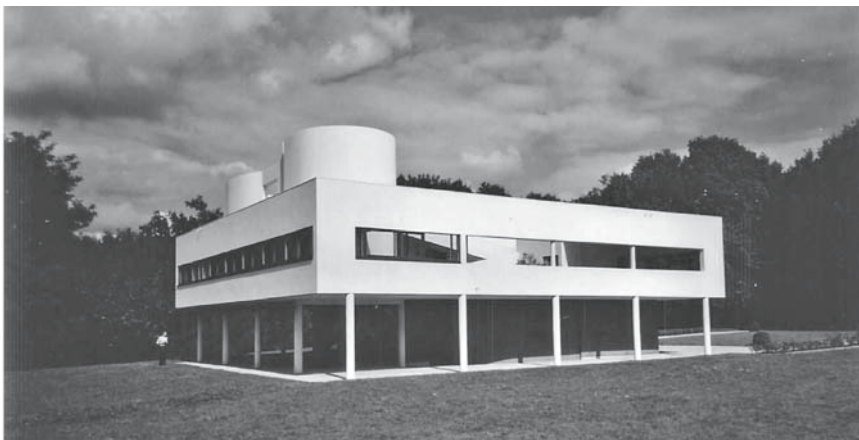
Figure 7. Savoye Villa.

The Savoye House was designed by the architect Le Corbusier, and was built in 1930 and represents a step towards the use of new principles and materials in residential construction [19]. The lower part contains an open covered parking area and a part for essential rooms. The main residential rooms are located on the floor above. Long horizontal openings enable a direct contact of people with tree tops and other nature surrounding the house. It should also be added that the villa was not constructed as an example of a building in flood-risk areas, but it is an excellent example of a structure that counters the myth of the needlessness and unsuitableness of residential architecture on columns (Figure 7).

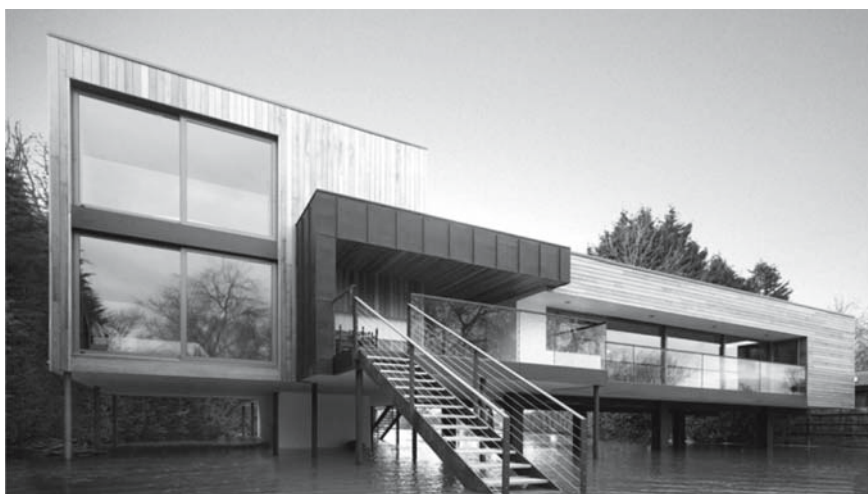
Figure 8. The Hind house

On the contrary, the Hind house built in 2008 by John Pardney architects, located next to the Loddon river at Wargrave was designed for the flood-risk area, since it was built on columns and is above the ground [20]. The basic concept is based on three elements: life, rest and socializing. The triple nature is reflected in the arrangement of rooms with large wings, which besides sleeping and living rooms and the central hall also include a room for exercise, an apartment for guests and a large terrace. The covered ground floor rooms are intended for parking. The house has a steel frame structure and the facades are covered with wooden and zinc lining. The roof is flat. Large glass windows represent an invisible barrier between the green of the embankment and the interior of the house. It enables the residents and guests an intensive experience and observation of changes in the nature, one of which can also be a flood. During a flood, the house is transformed into a home on the water and no longer a house next to the river (Figure 8).

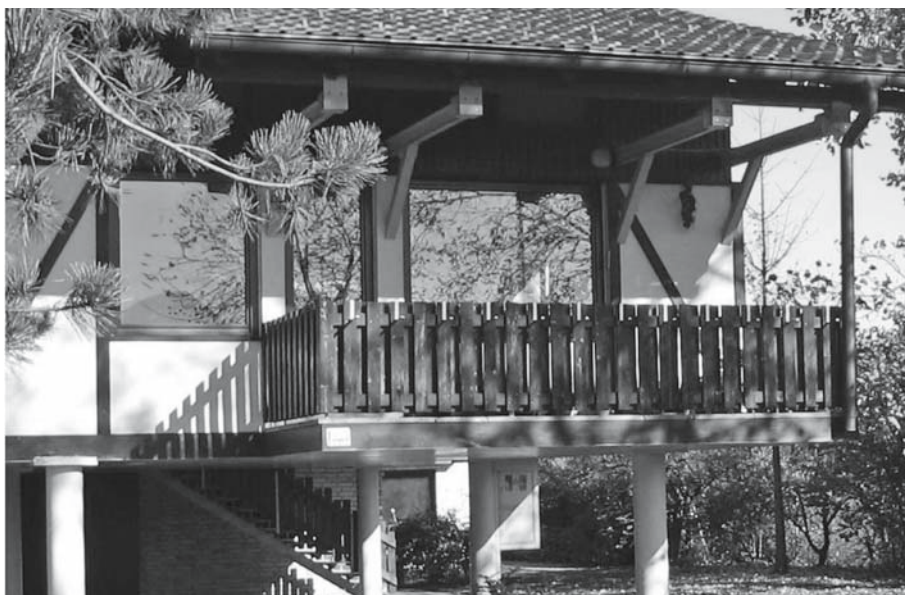
Figure 9. Picture of the house.

The “House on columns” was built in 2003 by architects D. and J. Kusar. Characteristic for the location of the building (Figure 9) is the natural marsh region with a flat landscape and rich willows next to drainage ditches. The basic concept of the structure followed the example of the dwellings of old inhabitants of this area who lived in pile dwellings, where instead of ancient canoes there is now enough space to park cars between the columns. The covered ground floor area and the storey are connected together with external single-flight stairs. The residential area has a rectangular layout with external dimensions of 10.24 x 12.7 m and is stands on nine round steel columns. The rooms are sensibly structured and connected according to their purpose and the marginal elements also comply with the structural requirements for low weight (Figure 10). This was made possible only with the use of light but strong materials. In this case, the load-bearing steel frame structure set up on nine round hollow steel columns, the composite plate and wooden roof beams and light partitioning drywalls. The load-bearing structure between the storey and the attic is made of wooden supports fixed to the inserted thermal and sound insulation. Because the entire house is “standing on air” the layer of external thermal insulation also has a suitable thickness (20 - 25 cm) which envelops the entire building.

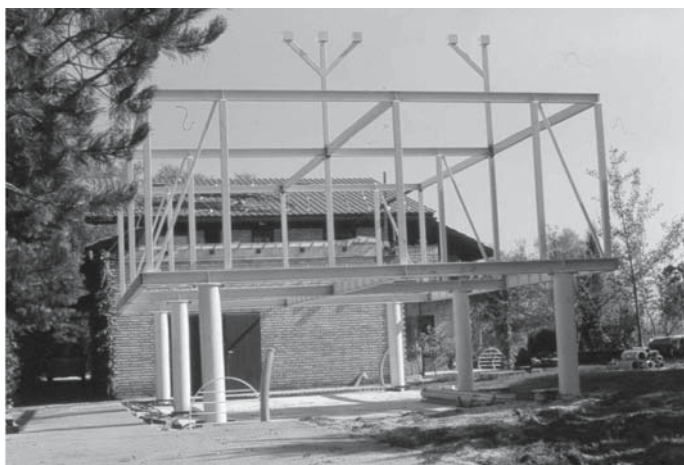
Figure 12. Picture of the structure during construction.

The main structural issue of the building (Figure 11 and 12) is the soft ground floor which is made of a grid of nine steel columns without horizontal wind bracing. The columns with a diameter of 324 mm and with a cover, having a thickness of 6 mm, are fixed to the foundation joist end and the composite plate of the first storey with moment screw joint. The screwing also enables the balancing of eventual differential subsidence as the result of the low bearing capacity soil. The grid of columns is 500 cm in one direction and 570 cm in the other. The main measure with which the dangerous effects of the soft ground floor were reduced is reducing the weight of the building on columns. Thus, a low-energy wooden house was built on the composite panel of the ground floor. By selecting and implementing the combined structure made from different materials, it was possible to achieve a weight of slightly less than 60 tons or approximately 800 kg/m². The static calculation of the support structure of the house takes into account additional amplifications of seismic accelerations that are created at the top of the ground floor (the so called “ground floor spectres”).
