# Pneumatic Tyre Aquaplaning: an Experimental Investigation on Manifestations and Influences of Appearance

*Abstract: Aquaplaning at wet road conditions and high speeds can be a source of dangerous driving situations and accidents. The proper understanding of characteristic effects can be crucial in early aquaplaning detection and accident avoidance, essential for driver and driver assistance systems and trajectory planning for self-driving cars. Four test vehicles were equipped with a basic measurement system, and measurements were performed to evaluate characteristics of aquaplaning, such as wheel spin-up and wheel spin-down, change of rolling resistance, tyre slip slope, and tie rod force. Driveline configuration, type, wear and inflation pressure of the tyre(s), water level height next to chosen speed and performed manoeuvre significantly affect vehicle behaviour and thus the possibility to detect aquaplaning conditions. The results and main findings may allow and help establish corresponding methods to early detect aquaplaning and dangerous driving conditions.*

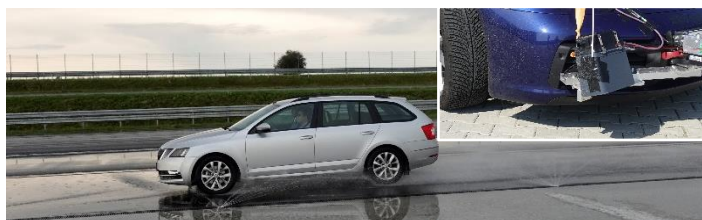
Figure 3

FWD Vehicle A on wet lane, watered with sprinklers; MARWIS sensor, [16], to measure water level heights

following signals were recorded during each of the test runs: individual wheel speeds, actual engine torque and speed, current gear, driveline engagement, steering wheel position, accelerator pedal position, brake pressure, and 3-axis accelerations/angular velocities from an inertial measurement unit (IMU). At the AWD vehicle also the tie rod forces were measured. The actual water level heights were continuously recorded by an optical Lufft MARWIS sensor [16], see corner of Figure 3.

For the FWD vehicle tests (vehicle A), a front-engine car was used, equipped with one year old medium worn summer tyres of dimension 205/55 R16V (~ 5 mm tread depth), Figure 3. The nominal tyre inflation pressure was 2.3 bar at the front tyres and 2 bar in the rear tyres. The mass of the vehicle was about 1450 kg during the tests.

constant water level height can be adjusted. For water level heights less than 2 mm, an asphalt lane without lateral grade was chosen with adjustable water sprinklers on the lane's left-hand side, see Figure 3, to set a defined water level height from 0.6-2 mm.
