14th-16th-CENTURY DANUBE FLOODS AND LONG-TERM WATER-LEVEL CHANGES IN ARCHAEOLOGICAL AND SEDIMENTARY EVIDENCE IN THE WESTERN AND CENTRAL CARPATHIAN BASIN: AN OVERVIEW WITH DOCUMENTARY COMPARISON

Andrea Kiss^{1,2*}, József Laszlovszky³

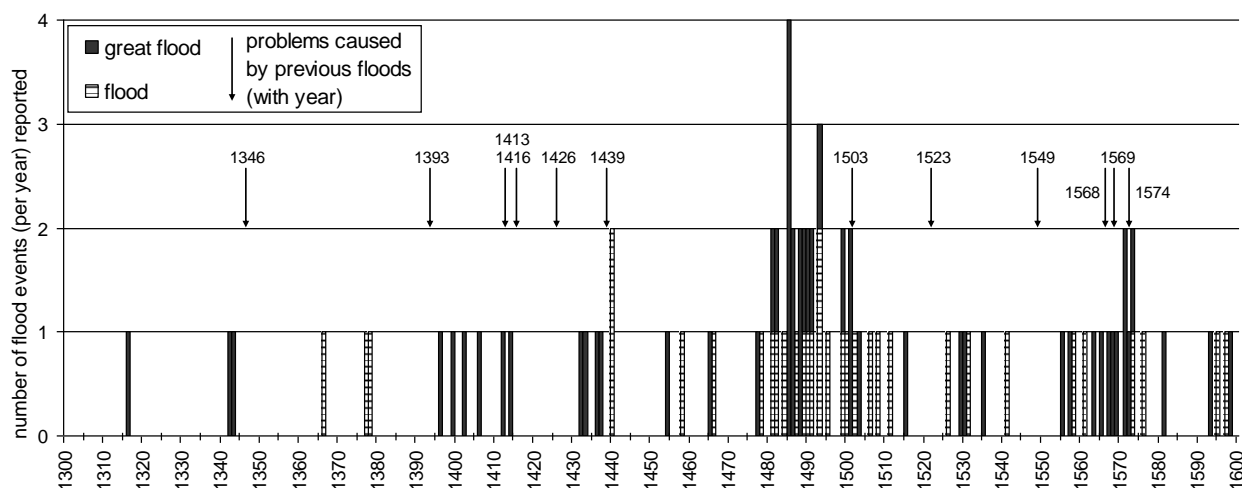
Fig. 1 14th-16th-century Danube floods in the Carpathian Basin, based on presently available documentary evidence (Sources: Kiss, 2012a, 2012b; Kiss and Laszlovsky, 2013)

Documentary evidence is mainly related to individual flood events or the relatively short-term consequences of preceding great flood events and therefore mainly provides high-frequency information. Archaeological and sedimentary evidence is mainly connected to the consequences of great or catastrophic flood events, flood-rich periods and long-term hydrological changes. Since dating of these events, periods and processes, with using natural scientific and archaeological methods, are usually possible on a multi-annual, multi-decadal level, archaeological and sedimentary data on floods are good indicators of medium- and low-frequency changes in flood behaviour. Nevertheless, documentary evidence can provide an important help in the possible more exact dating of flood events or flood peaks whose impacts could be observed in archaeological (and sedimentary) evidence (for presently available data, see: *Fig. 1*).

As a possible parallel, described in an official letter in 1549, short before the Danube at Bratislava also partly changed its bed, and floods were actively damaging the town walls (see Kiss, 1908; for more details see: Kiss, 2012b). Concerning this case, Ortway (1912) suggested that – similarly to the cases described by Fieber and his colleagues at Orth – an avulsion of the Danube channel occurred at Bratislava, and made the town walls (which were anyway in bad condition) more prone to destructive flood events. It is quite probable that this later event had connections to the great 1548 flood in Vienna mentioned above. Moreover, a number of flood events were also reported in contemporary documentation concerning the 1550s, and the great floods occurred practically in each year around the turn of the 1560s and 1570s (see Fig. 1).

The archaeological data on late 15th–early 16th-century floods is in good agreement with the information detected in documentary evidence: one of the most important (and certainly best documented) medieval flood peaks took place exactly around the decades of the 1480s, 1490s and 1500s (see Fig. 1).
